MORTUARY CHAPEL, MARYBOROUGH CEMETERY CONSERVATION MANAGEMENT PLAN

MORTUARY CHAPEL
MARYBOROUGH CEMETERY
WALKER STREET
MARYBOROUGH

Prepared for Fraser Coast Regional Council
Funded by the Queensland Heritage Grant Program
December 2010

Final report

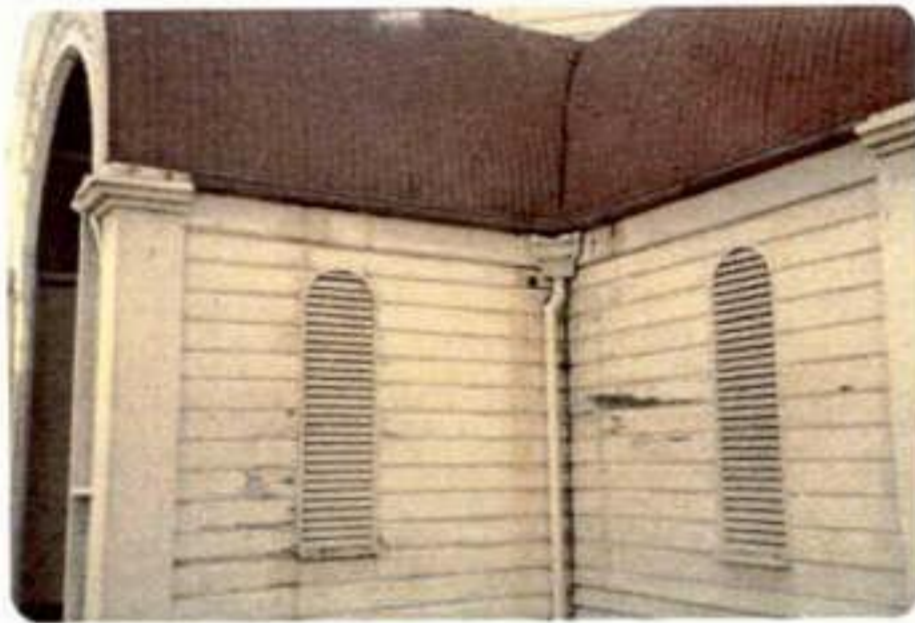
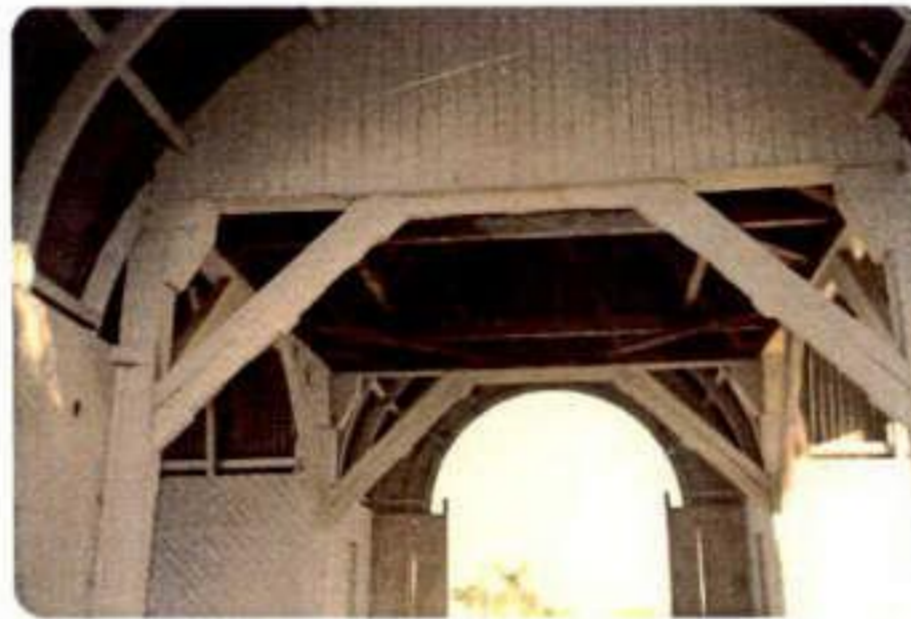
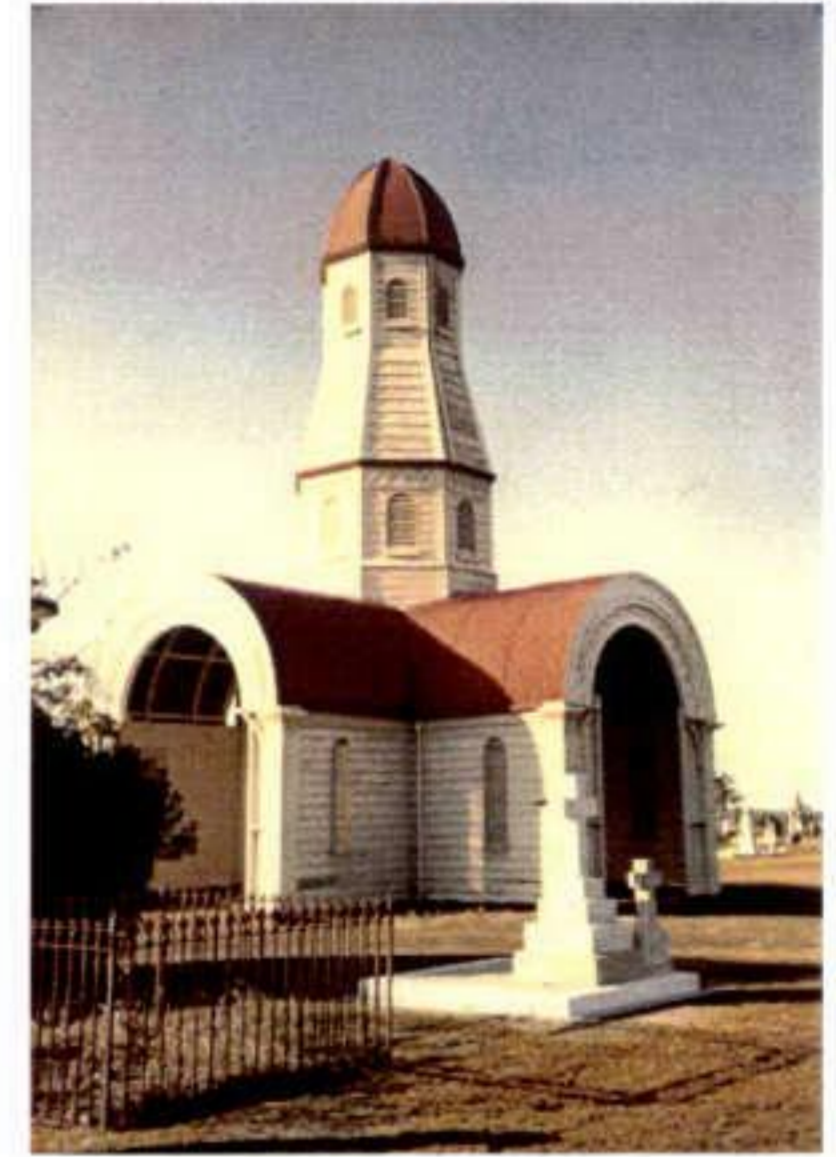
The deteriorated roofing and non-functional drainage has allowed the elements access to the timber frame of the building. Water penetration has caused extensive deterioration of the frame, external cladding, and internal lining. Much of the louvre joinery and adornment is deteriorated. The tower's ceiling has fallen out, exposing its frame.³⁰

Structural timbers at this time are recorded as in acceptable condition with some dry rotted and deteriorated sections – mainly due to water damage. Pine timbers of the barrel vaults (all rounded and curved timbers of keyed lengths) were recorded as being in poor condition.³¹

Figures 14-16. Mortuary Chapel 1983. Photos taken to accompany grant application to undertaken works.

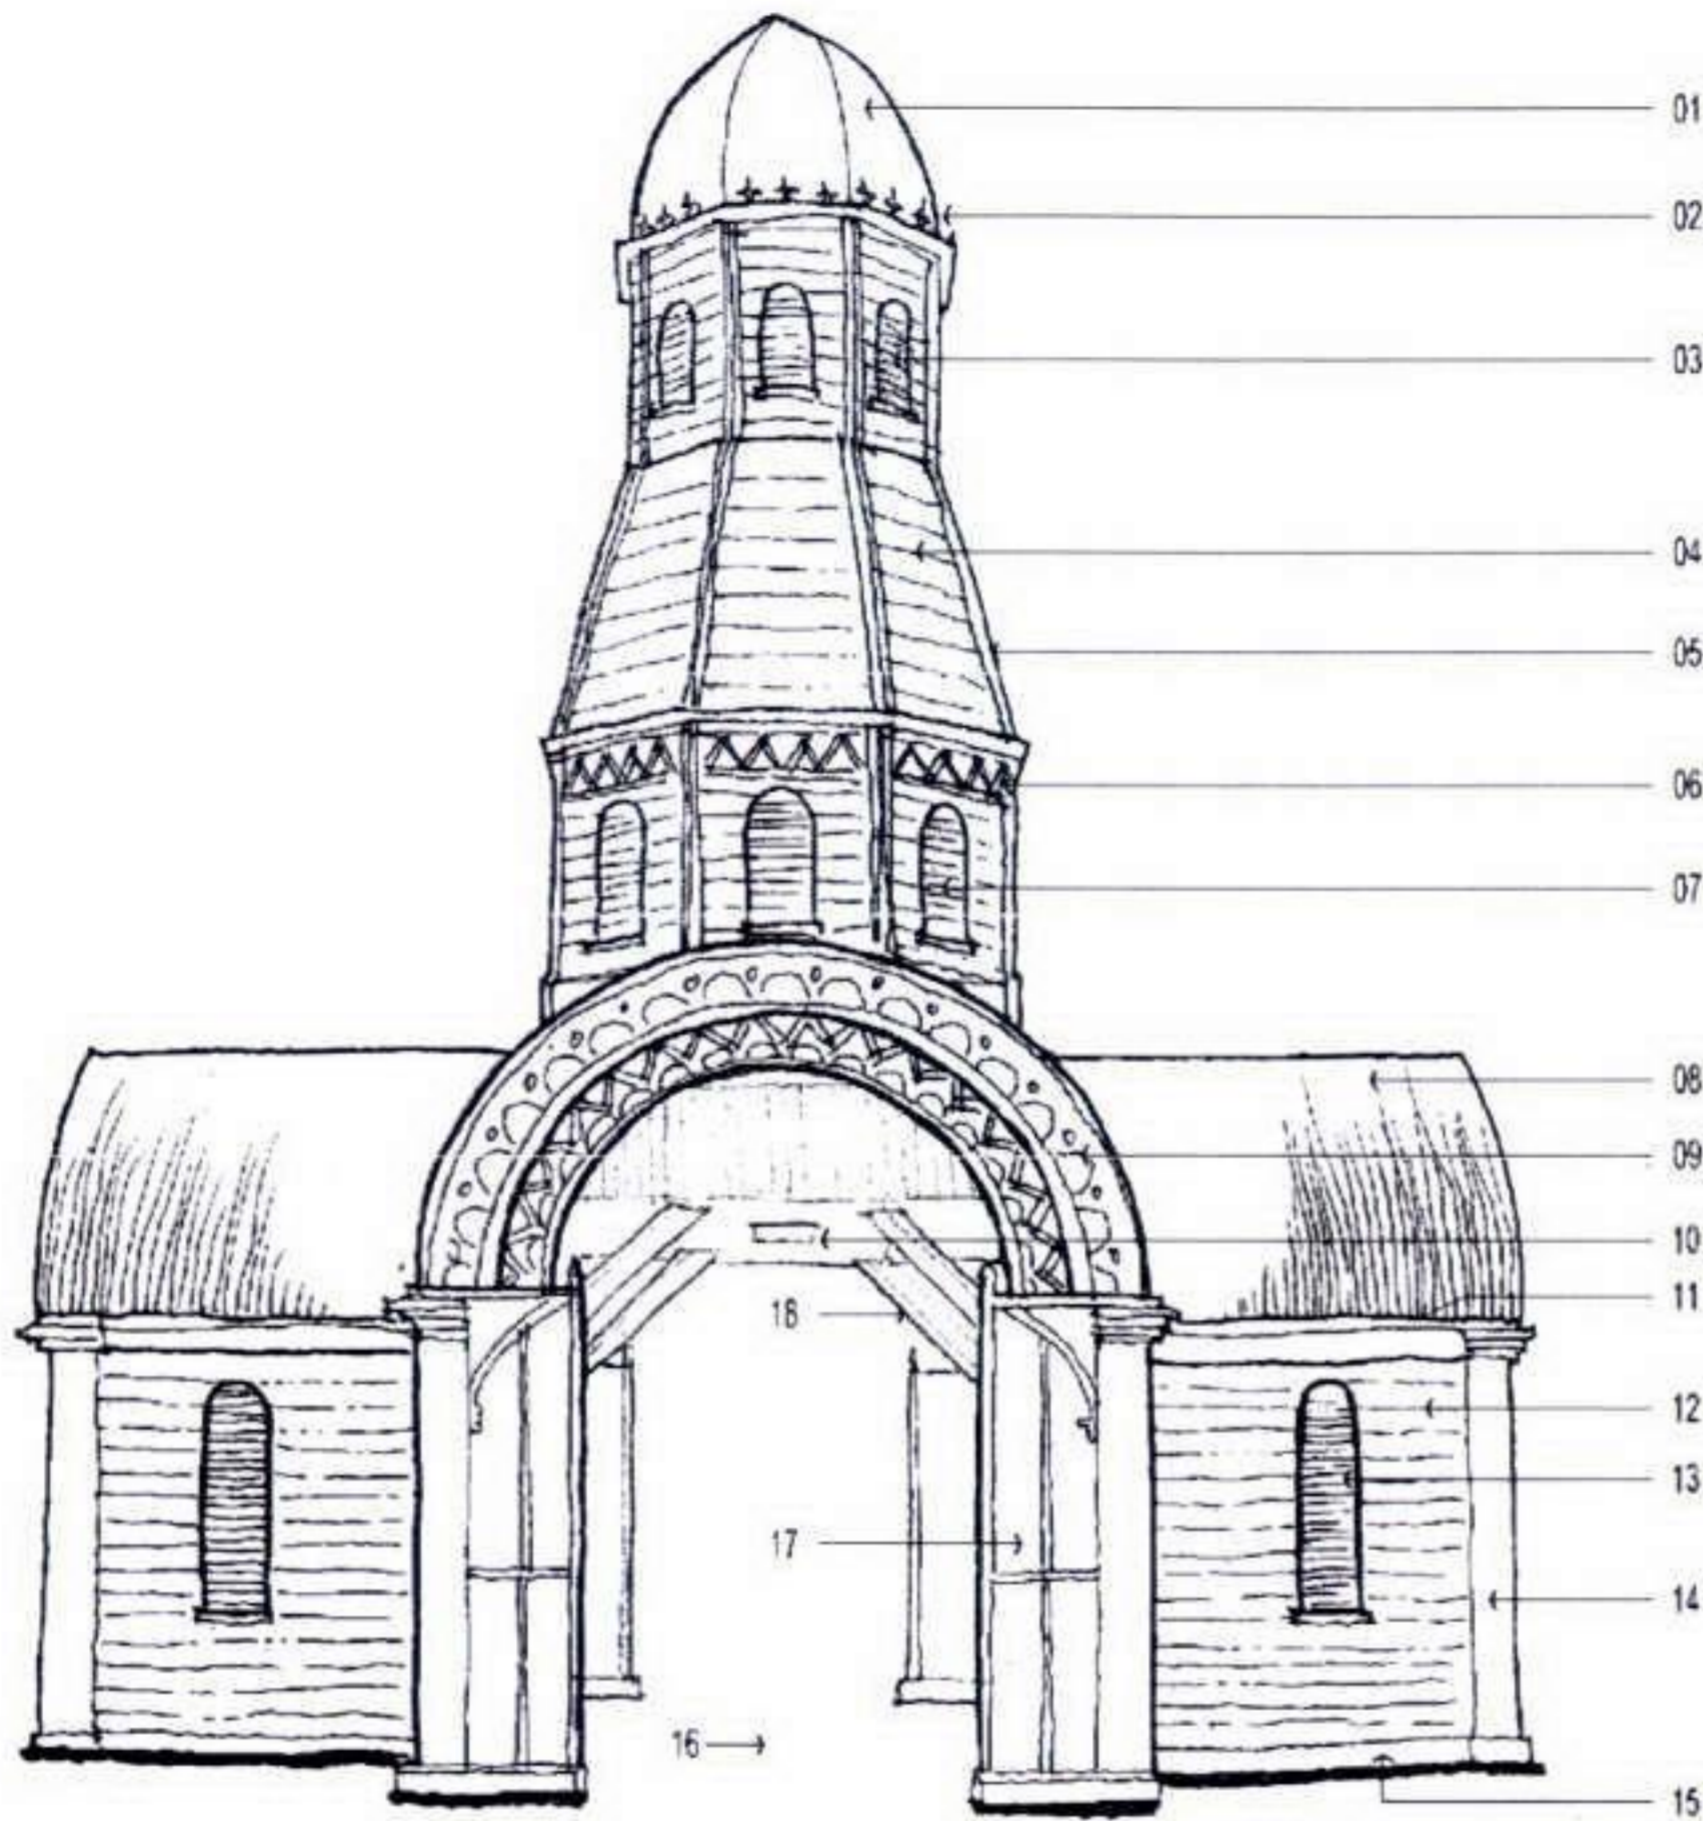
Figure 26. Sketch exterior – breakdown of elements.

01. The Cupola roof is clad with painted sheet metal (possibly flat galvanised metal sheet). It has painted profiled and curved lead ridge cappings. During the 1983 restoration the metal roof sheeting and cappings were replaced, including the replacement of the timber substrate frame.

02. The painted galvanised steel ‘ogee’ profile gutter has an integral cut-out metal frieze. The gutter was replaced during the 1983 restoration and the decorative frieze was retained and reinstated after straightening and galvanising.

03. Timber framed arched openings with fixed timber louvres and timber sills appear on all faces of the chapel walls and cupola. Some of the window mouldings and louver blades were replaced during the 1983 restoration. The louver windows have a paint finish.

04. Vertical surfaces of the fleche (tower) are clad in chamfer board in a paint finish. Some damaged / missing boards and the pine substrate frame were replaced during the 1983 restoration. Sloping surfaces of the tower are clad with weatherboards. Photographic evidence prior to the 1983 restoration verifies that these weatherboards existed then also. It is a curious choice of material for a cladding surface so exposed to the weather. Often sheet metal, timber shingles or weatherboards with nicks cut out to resemble shingles were used in this situation.

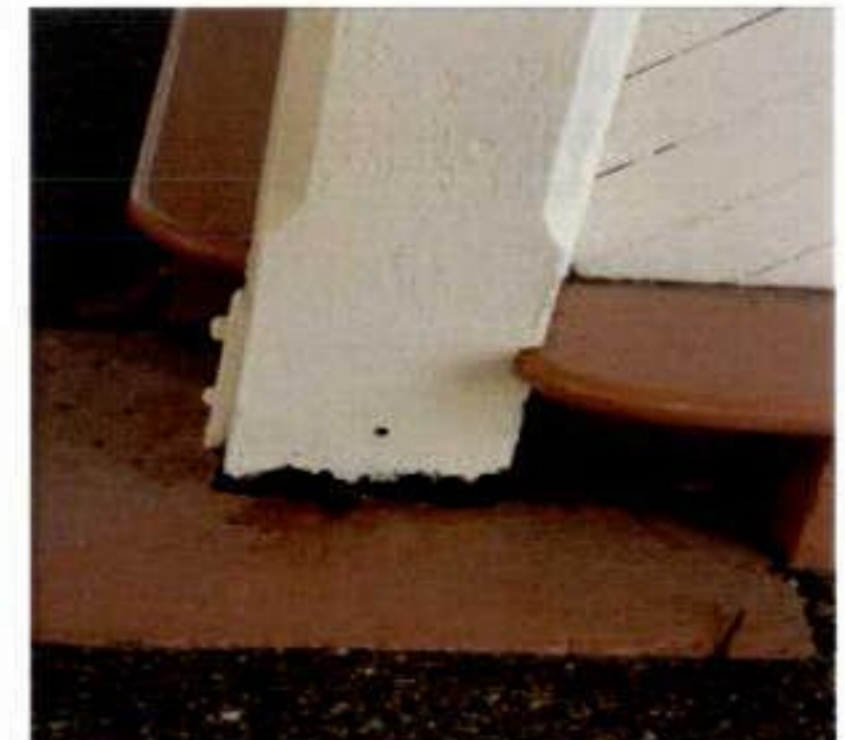
Figure 28. (top) Existing masonry base of timber post in relation to internal ground level.

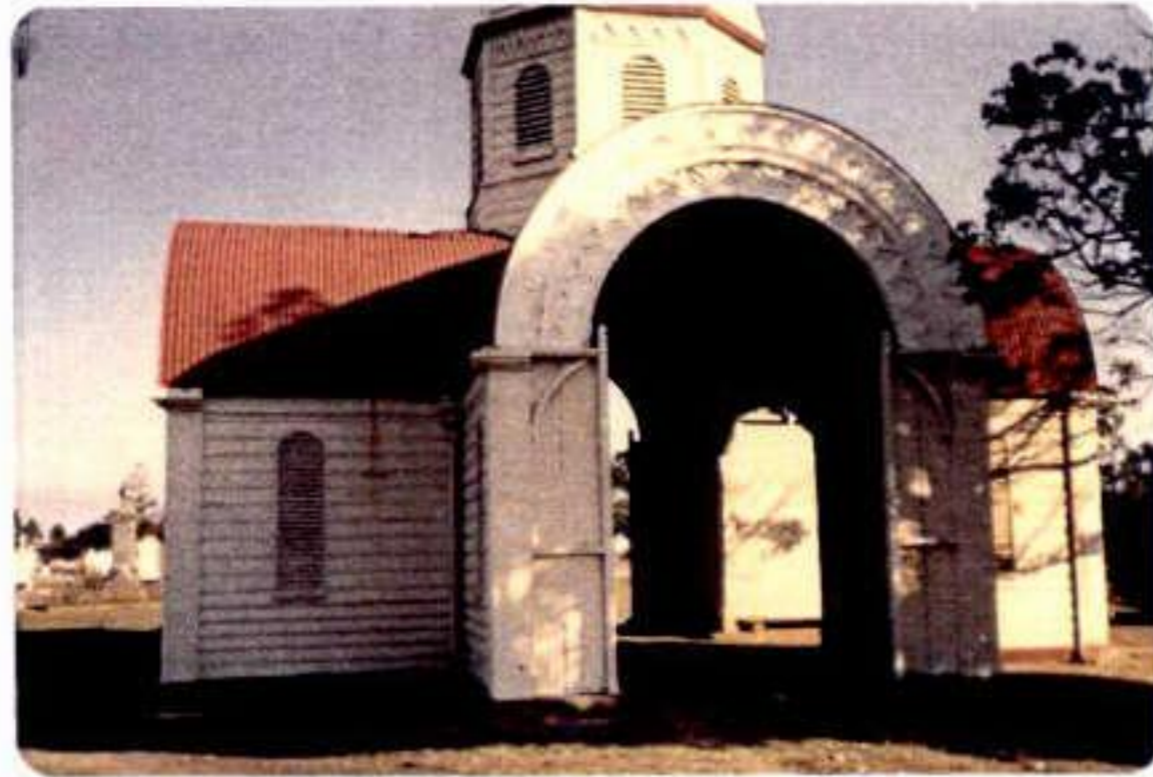
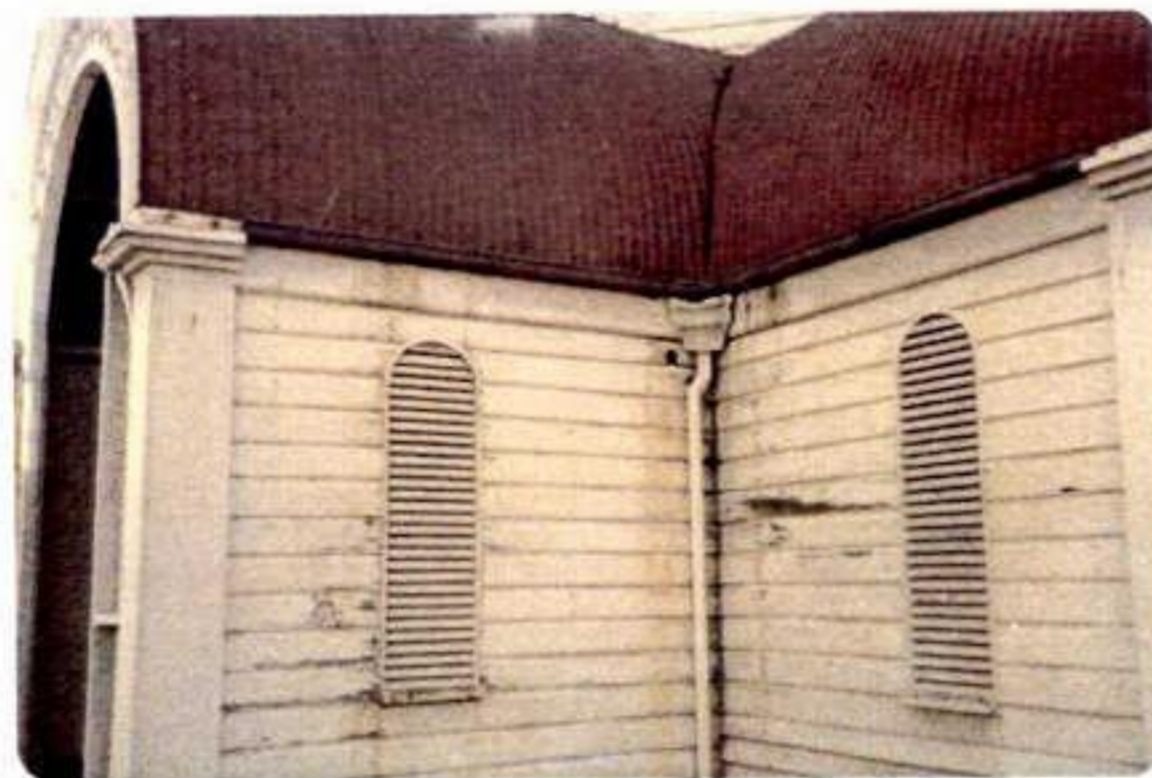
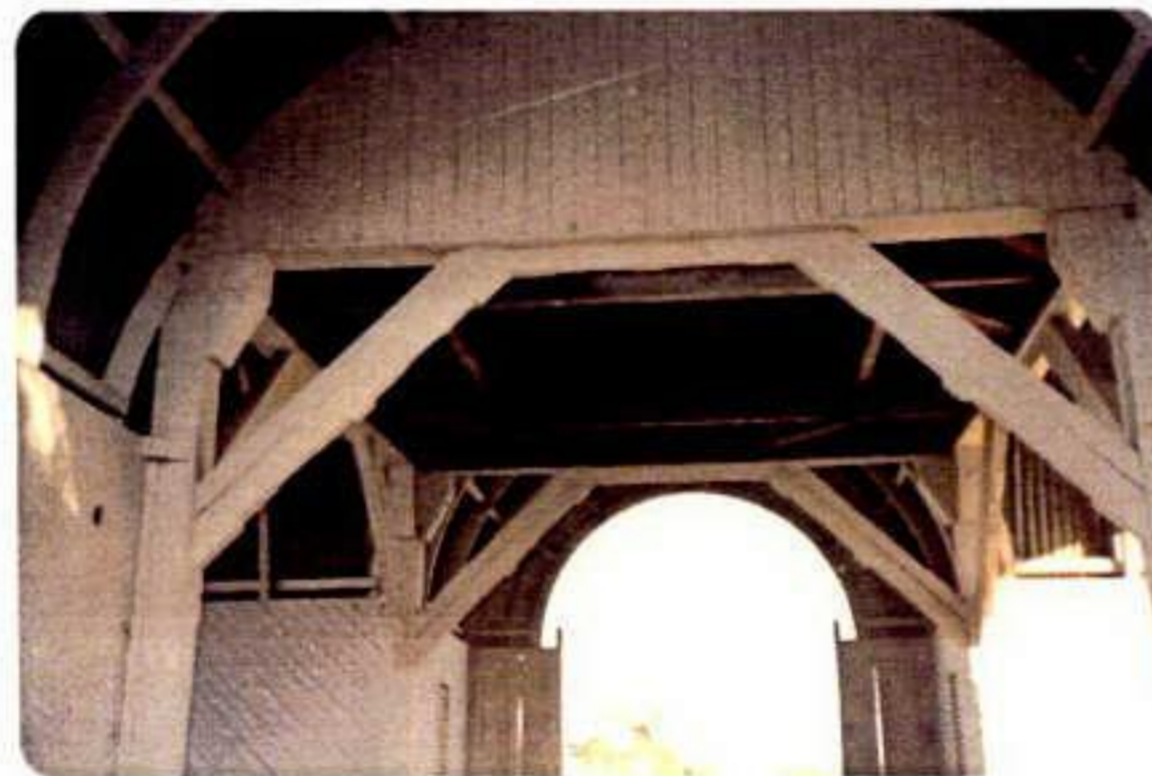
- TOP - View Illustrating Transept Entrance.
CENTRE - Exterior Junction of Transepts and Barrel Rooves.
BOTTOM - Interior Junction of the Transepts.

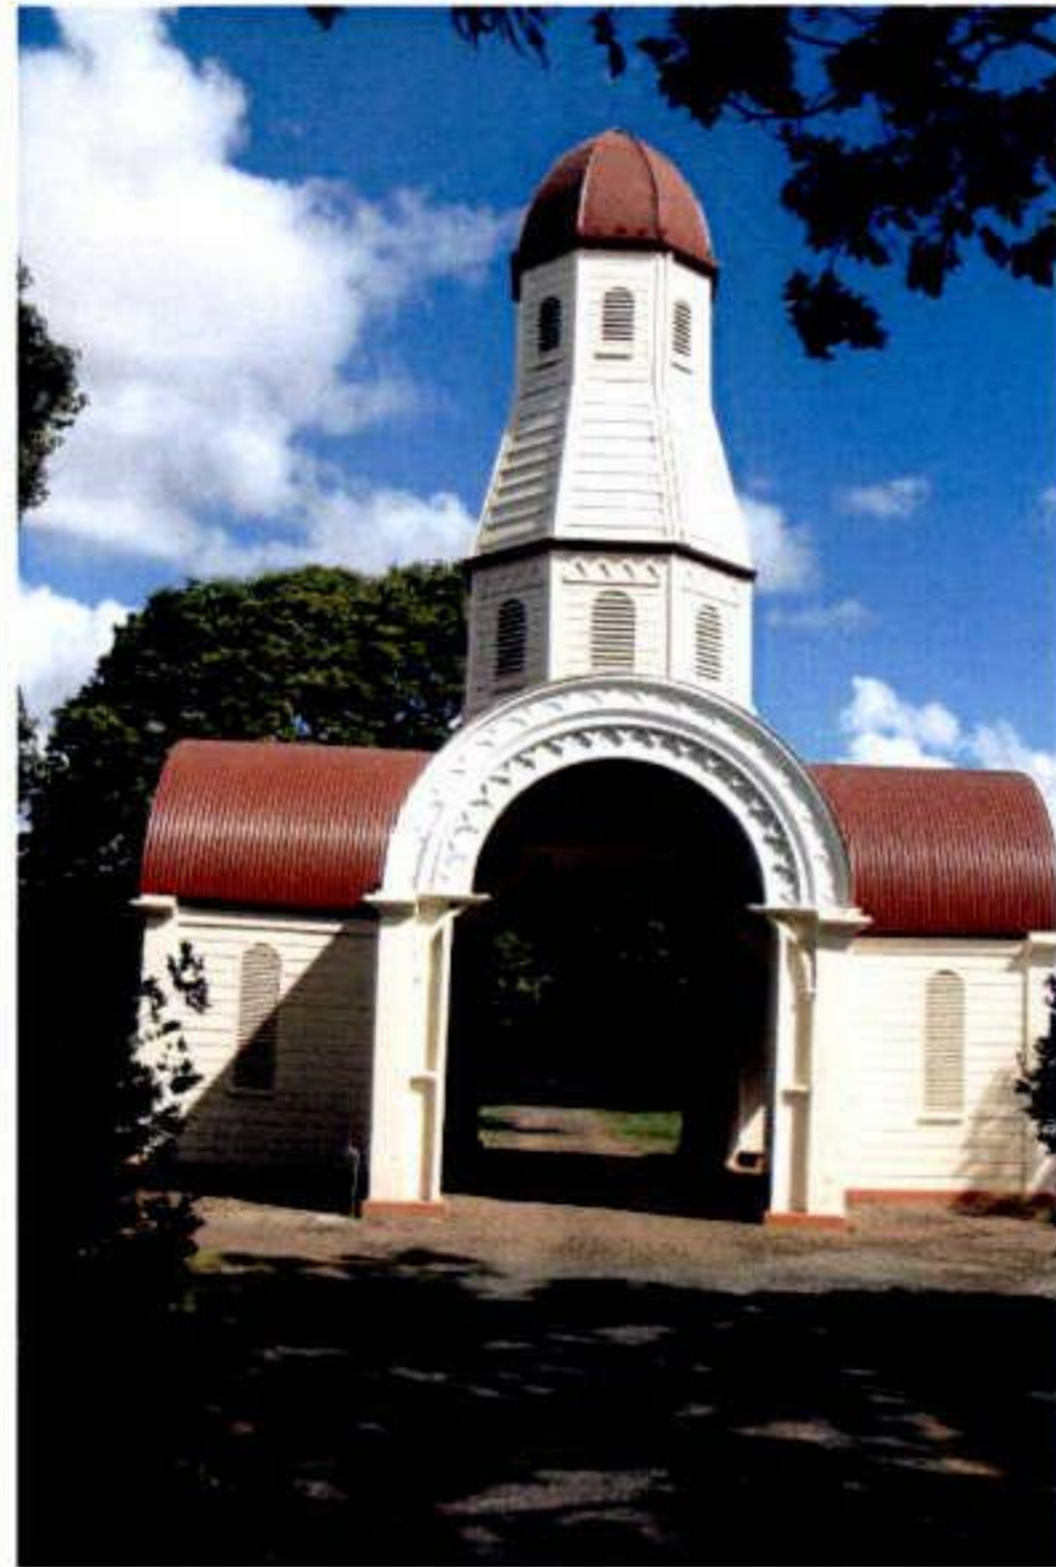
01 North/south axis entry showing the northern elevation of the chapel. Much of the chapel's external fabric was repaired or replaced during the 1983 chapel restoration. (see the fabric survey)

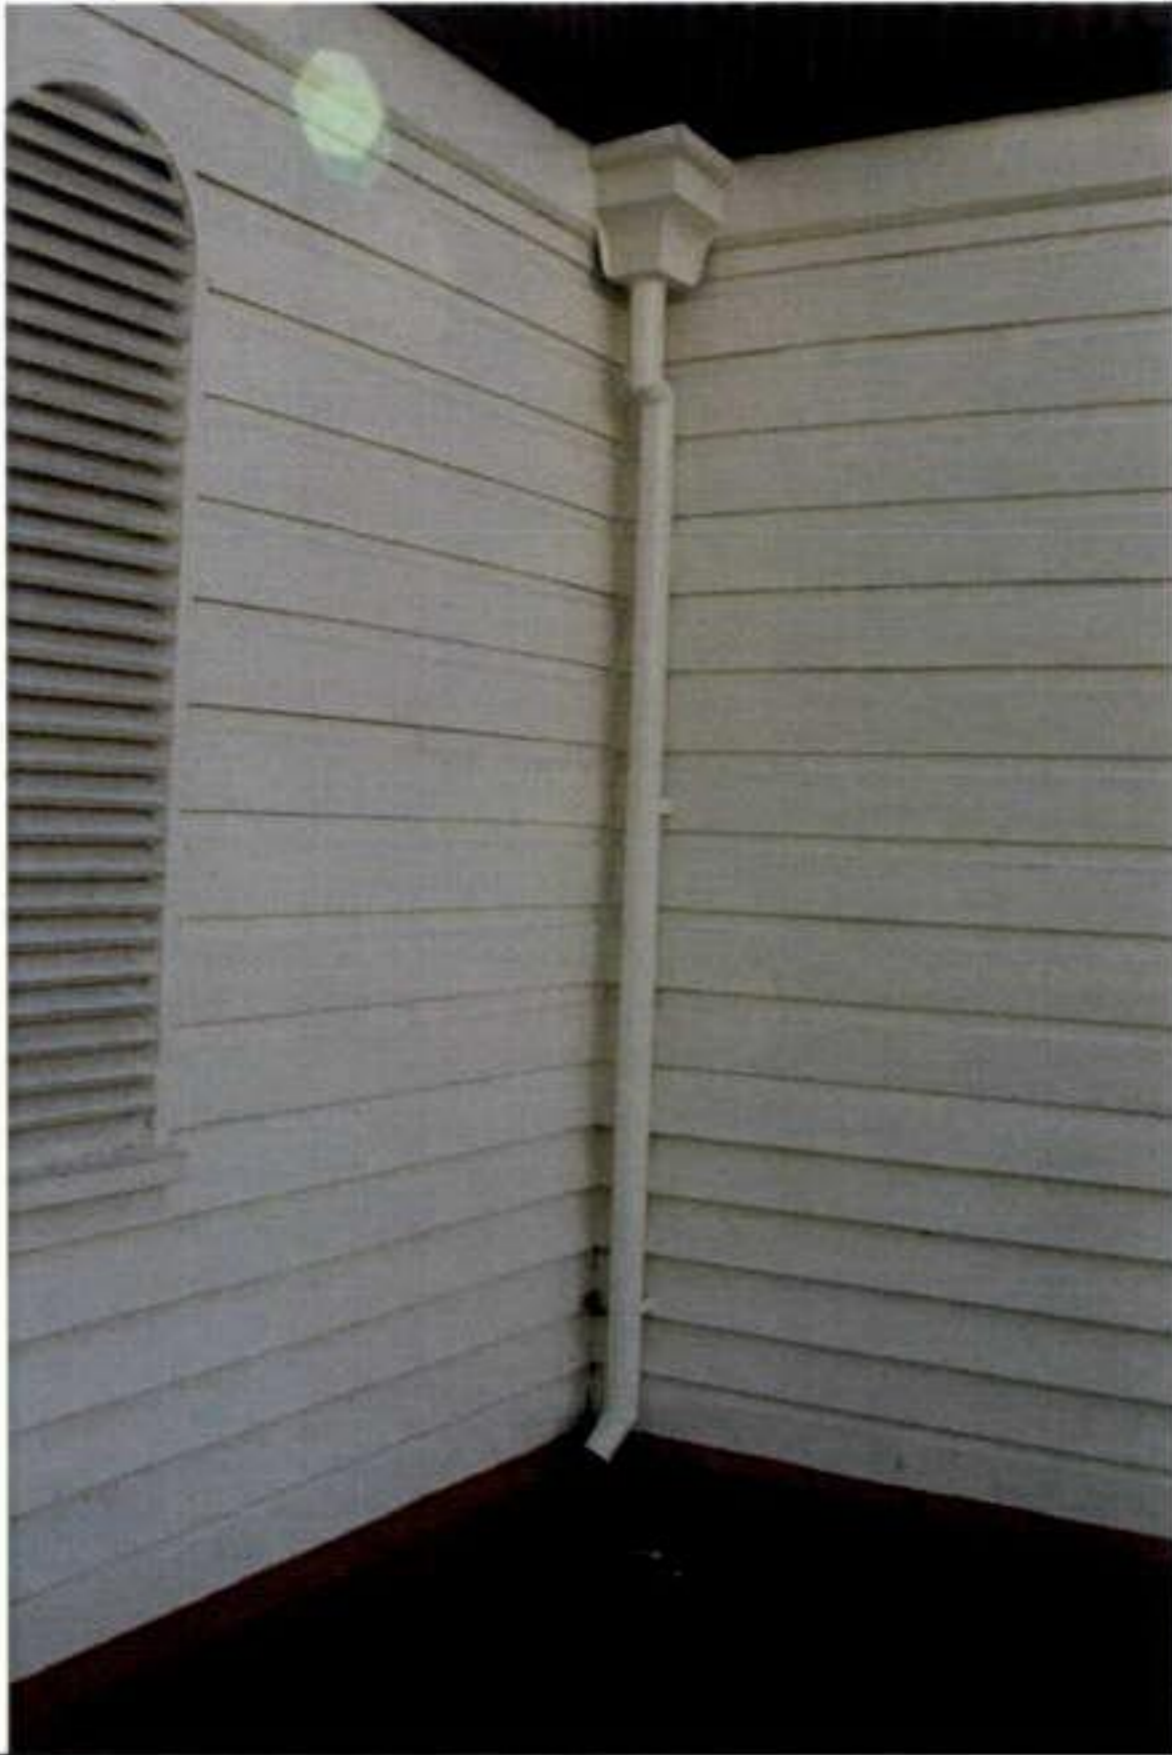
04 Downpipe detail. The Downpipes are currently shedding water against the walls which could cause future damp issues.

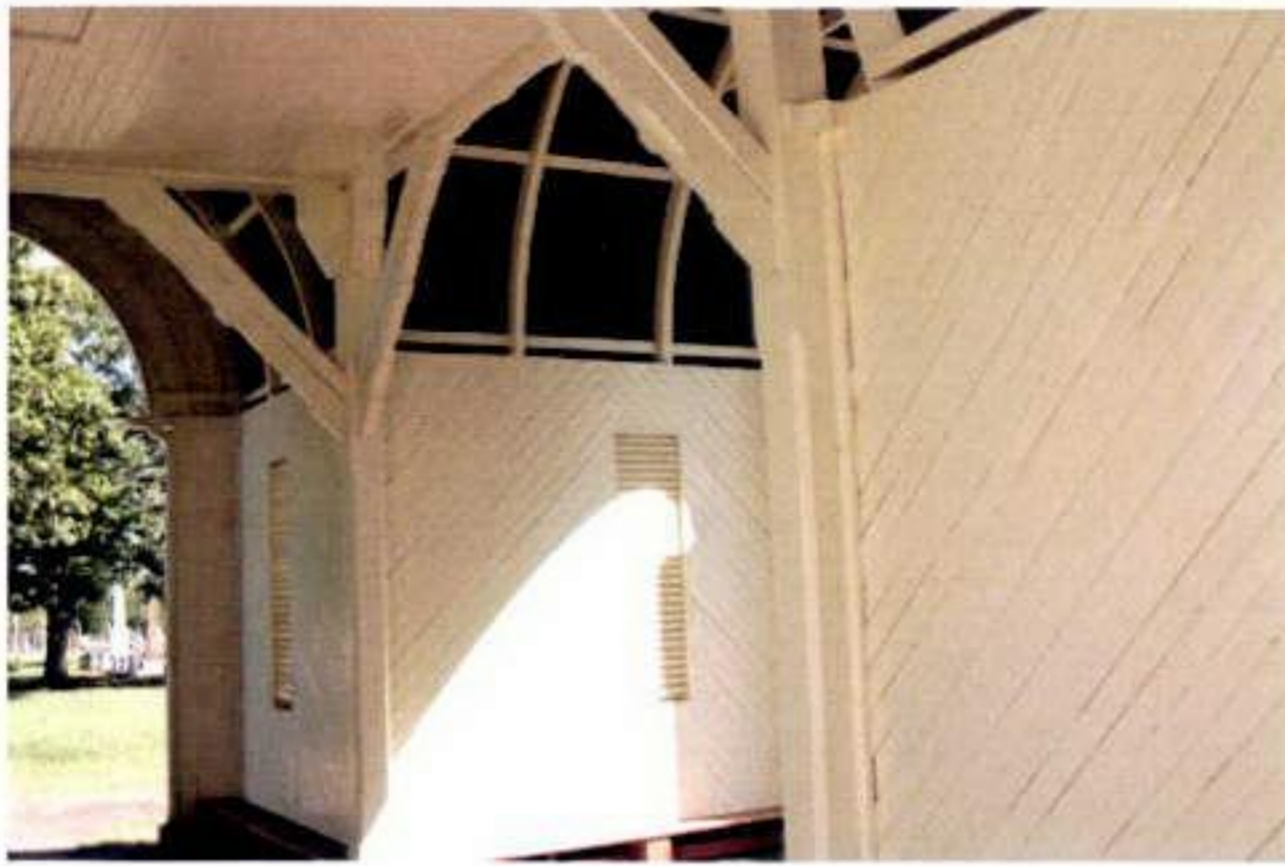
08 A typical interior view of the chapel. As part of the 1983 restoration the ceiling shown with central manhole was completely replaced, and ceiling joists were installed to compensate for downward bowing of the original frame.
