LOWLANDS LAGOONS (ANEMBO LAKES) WATERBODY MANAGEMENT PLAN

DesignFlow
Prepared for Fraser Coast Regional Council
February 2021

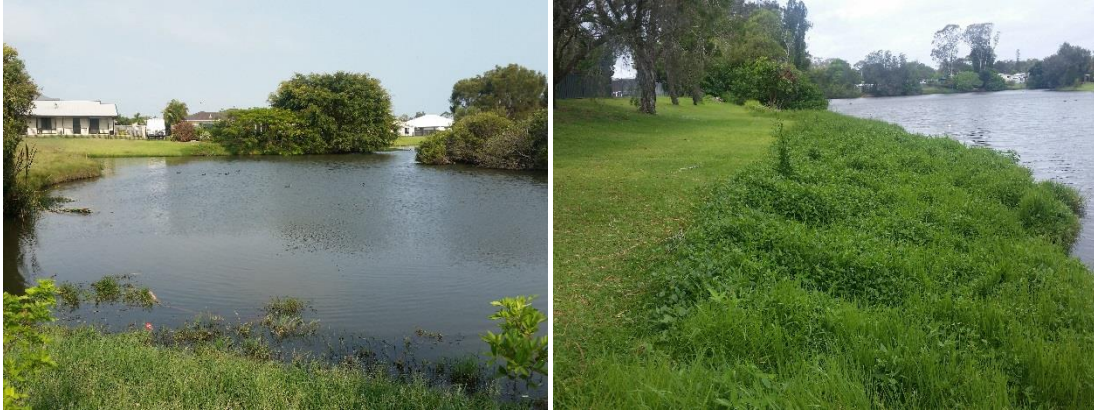
Figure 3-1 Waterbody A – a) Eastern end, and b) Edge buffer zone established by Council.

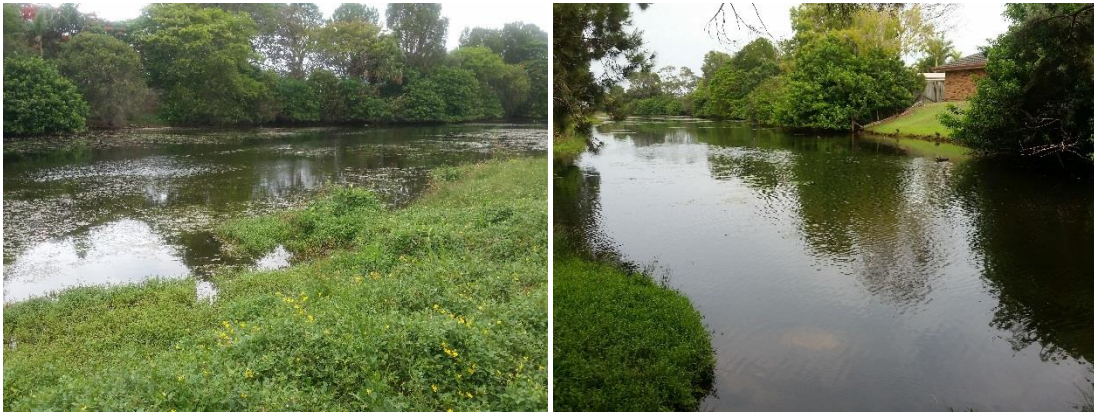
Figure 3-2 Waterbody B – a) Shallow water with dense growth of *Ceratophyllum demersum*, and b) Deeper water at eastern end of waterbody.

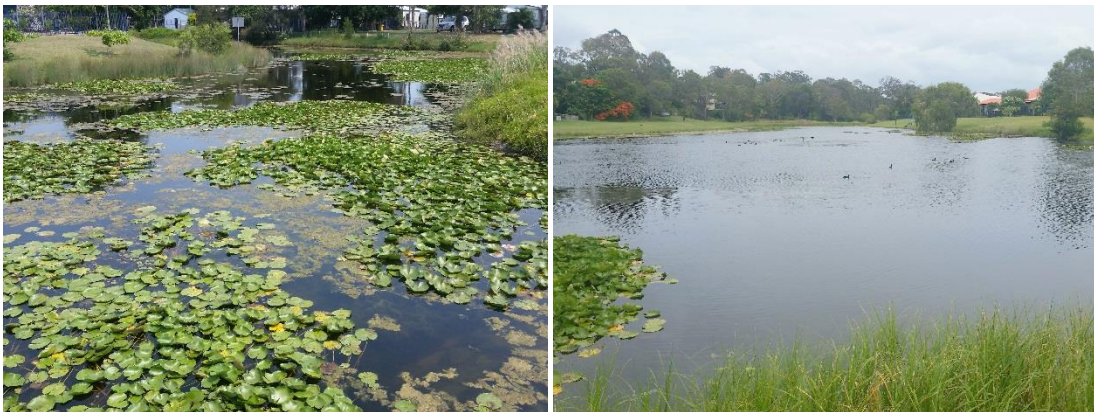
Figure 3-3 Waterbody C – a) Dense cover of *Nymphaea mexicana* near outlet to Waterbody D, and b) Main waterbody.

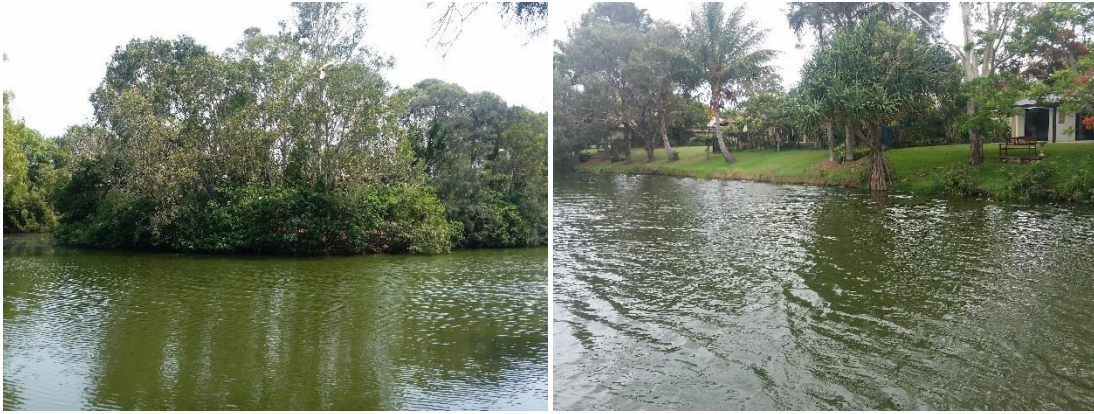
Figure 3-4 Waterbody D – a) Anembo Island – Ibis rookery, and b) Steep batters along the southern edge with steep drop-off at the water's edge.

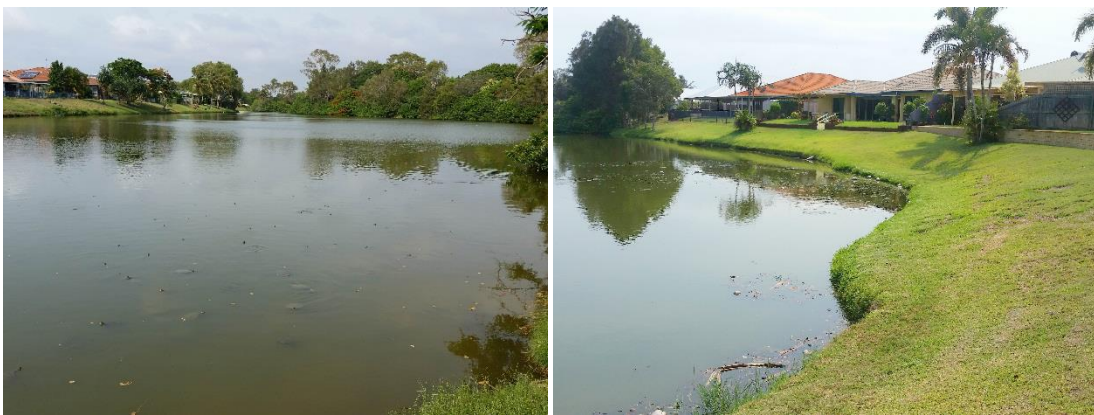
Figure 3-5 Waterbody E – a) Main waterbody (turtles waiting to be fed in foreground), and b) Example of residents mowing batters to the water's edge.

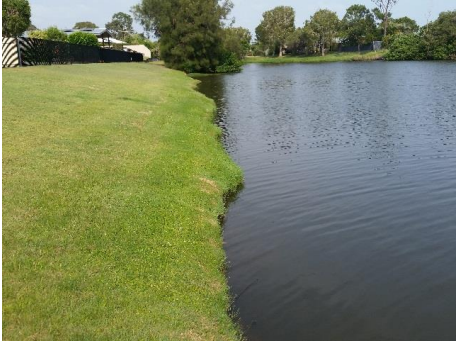
Edge Type	Comments/notes	Photo
Gentle batter +/- sharp drop off into shallow water	Generally >1:3 batter slope, mown grassed edge +/- sharp drop off into shallow (<0.3m) water. Moderate risk but shallow depth of water means exiting is fine. <u>Safe</u>

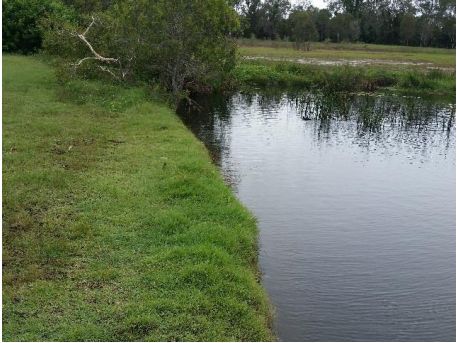
Gentle batter +/- sharp drop off into deep water	Generally >1:3 batter slope, mown grassed edge +/- sharp drop off into deep (>0.3m) water. High risk as deep depth of water means exiting may be difficult. <u>Potentially Hazardous.</u>

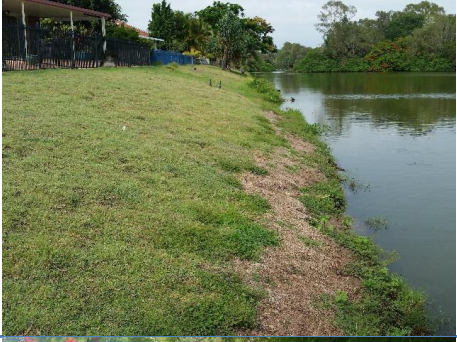
Steep batter +/- sharp drop off shallow water	Generally <1:3 batter slope, +/- sharp drop off into shallow (<0.3m) depth water. Moderate risk but steep batter slope may make it very difficult to exit waterbody (and easy to fall back in). High drowning risk <u>Potentially Hazardous</u>

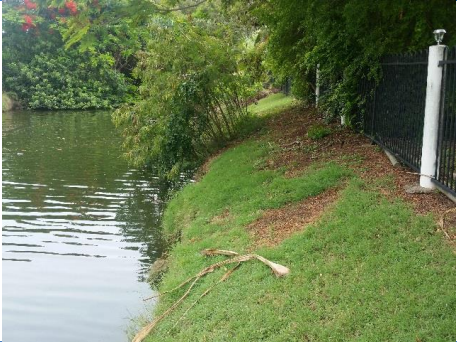
Steep batter +/- sharp drop off deep water	Generally <1:3 batter slope, +/- sharp drop off into deep (>0.3m) water. High risk as steep batter slope and deep depth of water means exiting is extremely difficult (and easy to fall back in). High drowning risk <u>Hazardous</u>

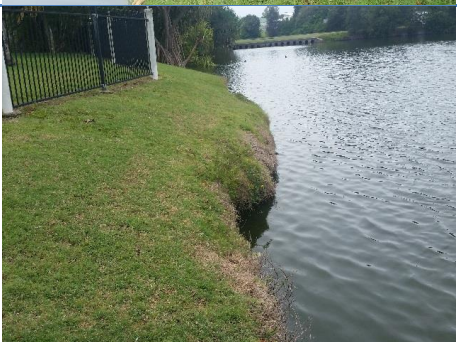
Vertical/highly eroded edge	Vertical waterbody edge with drop off into +/- deep water. Extremely difficult to exit waterbody. Presence of deep water means high drowning risk. <u>Extremely Hazardous</u>

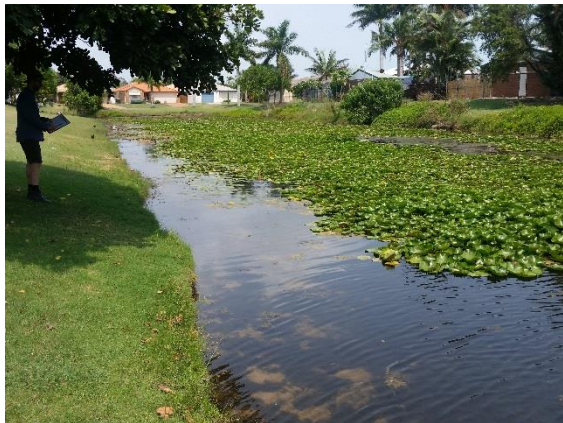
The majority of the lower batters/edges have good vegetation cover and are stable. Many of the waterbody edges comprise of mown grass, and have shallow vertical edges where wave action or waterbird activity has resulted in minor scour (Figure 4-1). These edges are relatively stable but are highly susceptible to further scour due the presence of the bare soils.

Figure 4-1 Minor scour present below grassed edges creating shallow vertical edge.

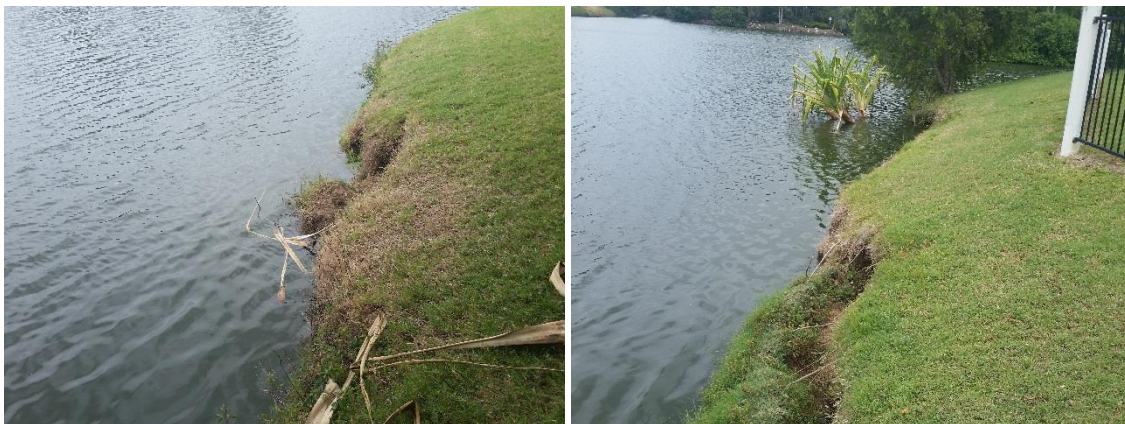
Active erosion and undermining of the waterbody edges along the northern margin of Waterbody D and within the Anembo Drive inlet are of most concern, as the batters are steep to vertical, adjoining deep water and represent a risk to both public safety and the adjoining residential properties.

Of particular concern and requiring urgent attention, the waterbody edge adjacent to the residential property to the east of Anembo Drive inlet is severely undermined, is actively eroding and is retreating towards the property boundary. Intervention will be required to arrest the erosion and protect the residential property boundary. A similar scenario is occurring along the waterbody edges adjacent to this area, but the batters are moderately stable and not endangering the adjacent properties.

Figure 4-2 Eroded areas within Waterbody C: a) northern edge, and b) near Anembo Drive inlet.

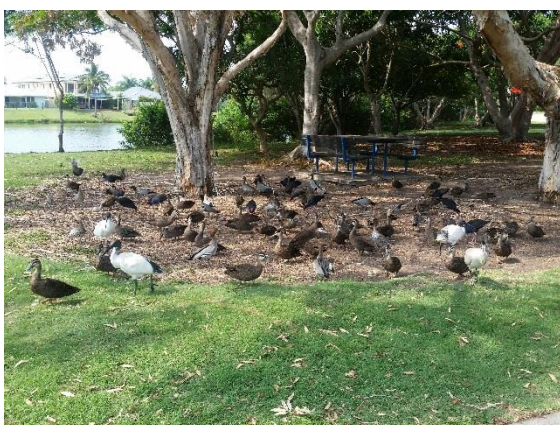
Daily feeding of the waterbirds occurs within the park between Truro Street and Waterbody E, resulting in a major aggregation of the waterbirds every morning and high loads of faecal matter present within the park (Figure 4-4).

Figure 4-4 Bird feeding area within the parkland on Truro St.

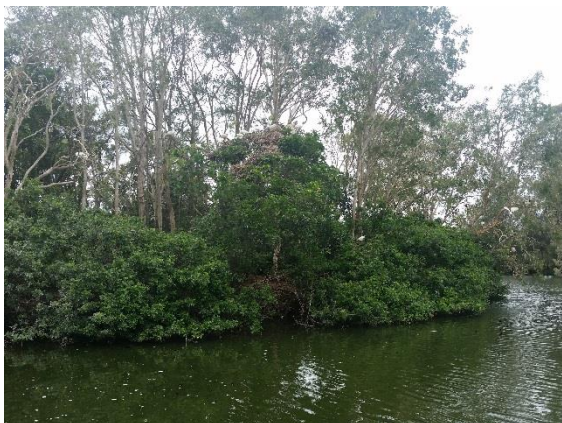
Areas within the waterbodies where waterbirds congregate are considered to be associated with a potentially higher risk, as there is generally higher deposition of bird faeces in these areas. This includes the areas (both the water and waterbody edges) adjacent to the Ibis rookeries (Waterbody D - Anembo Island and small island, Waterbody E - island). The waterbody edges behind the residential properties and adjacent to the Ibis rookery on Anembo Island were notably contaminated and notably odorous during the waterbody inspection (Figure 4-5).

Figure 4-5 Ibis rookery on Anembo Island.

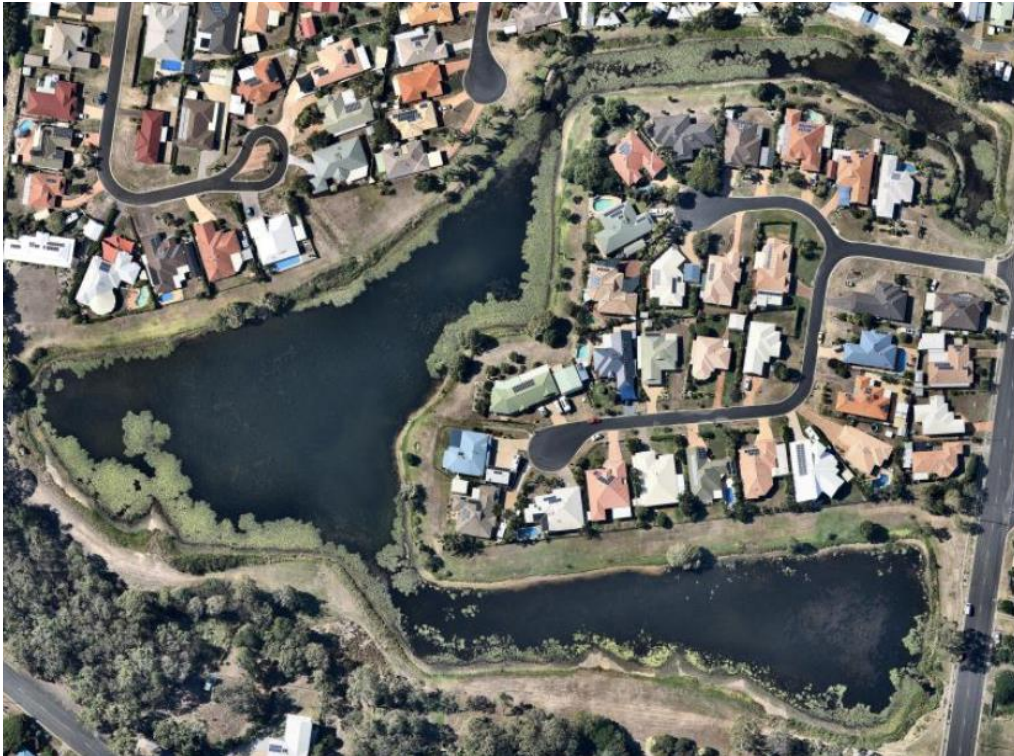
Figure 4-6. *N. mexicana* (light green areas) around margins of Waterbody C.

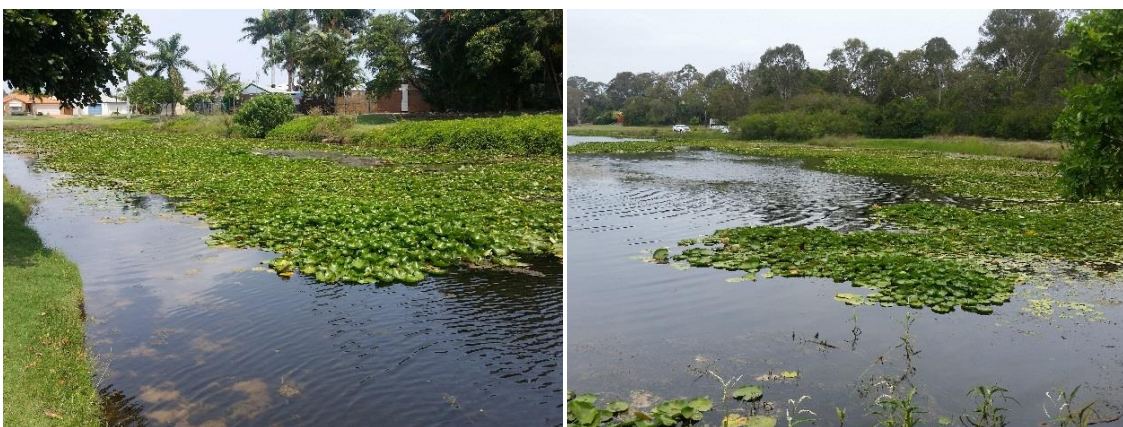
Figure 4-7. *N. mexicana* – a) Northern arm of Waterbody C, and b) Extensive population along the southern edge of the waterbody.

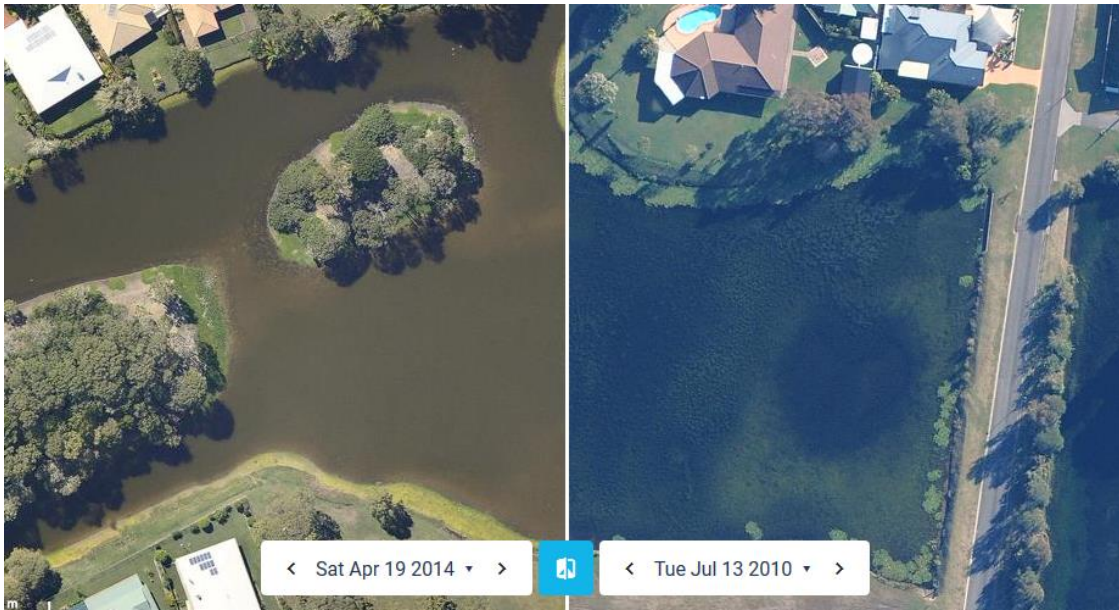
Figure 4-8 Waterbody D – comparison of submerged waterplant cover between 2010 and 2014.

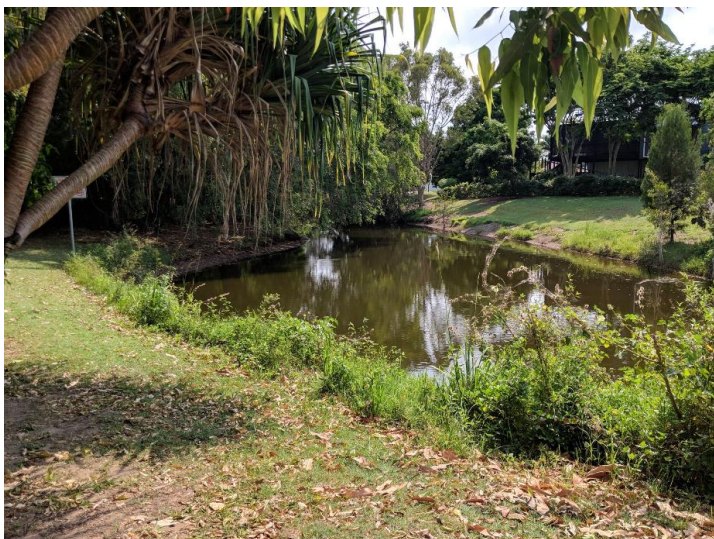
A number of 'backwater' areas were noted in Lowlands Lagoons. Backwater areas within the waterbodies can often have longer residence times as they are poorly flushed. Backwater areas often appear stagnant and are associated with the accumulation and decomposition of organic material. Poorly flushed waterbody water combined with nutrient release (e.g. from anoxic sediments or bird faecal matter) often results in ideal conditions for incubating algal and floating water weed growth (Figure 4-10).

Figure 4-10 Backwatered areas such as Anembo Drive inlet can act as incubators for algal and floating waterplant growth.
