General Assessment of 2 Trees on the proposed Cultural Centre Site adjacent Library on Old Maryborough Road, Hervey Bay.
By Paul McDermott

TREE HAZARD EVALUATION FORM

Tree Hazard Evaluation Assessment- Albizia and Norfolk Island pine at Discovery Sphere

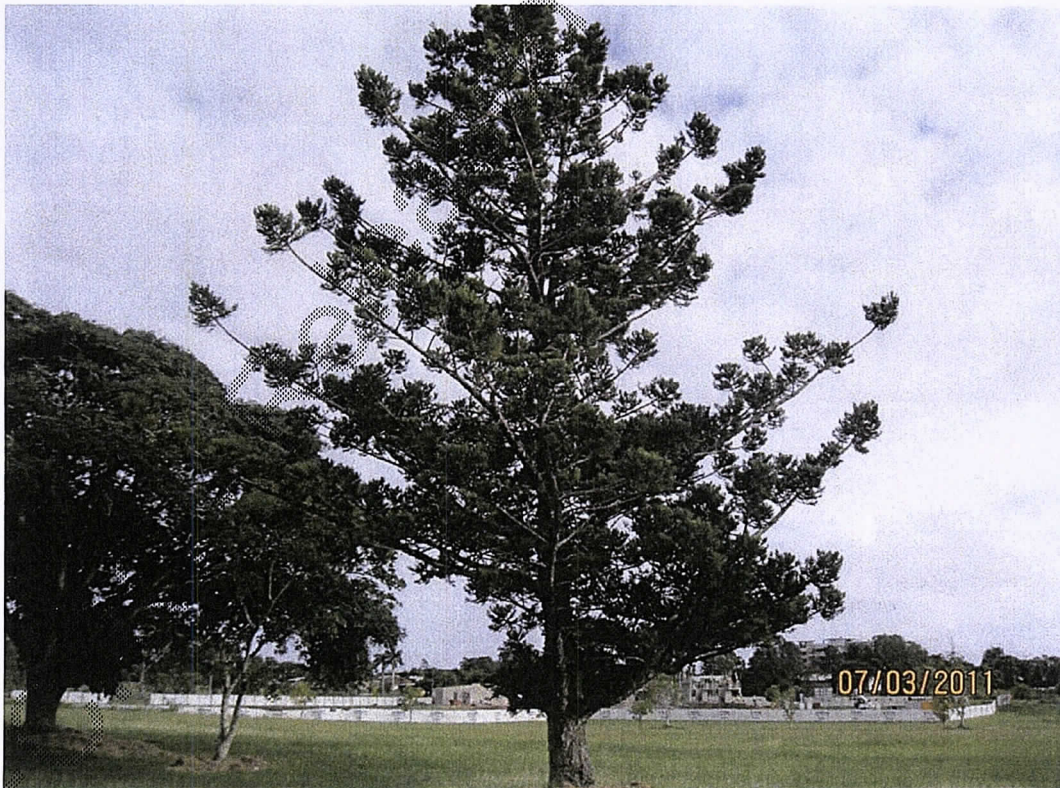
Tree 1. *Auracaria heterophylla* –Norfolk Island Pine

This Norfolk Island pine tree is approximately 15m high with a spread of 8m. DBH 700mm. The tree is quite healthy although due to possible storm damage some time ago the main leader had been damaged causing a second smaller leader to grow. If determined by an aerial inspection this second leader could be removed. The lower branches of the tree could also be removed. Placement of grass clippings at the base of the tree is detrimental to the tree's health. The tree has a potential to grow 50-65 m in height, although slow growing

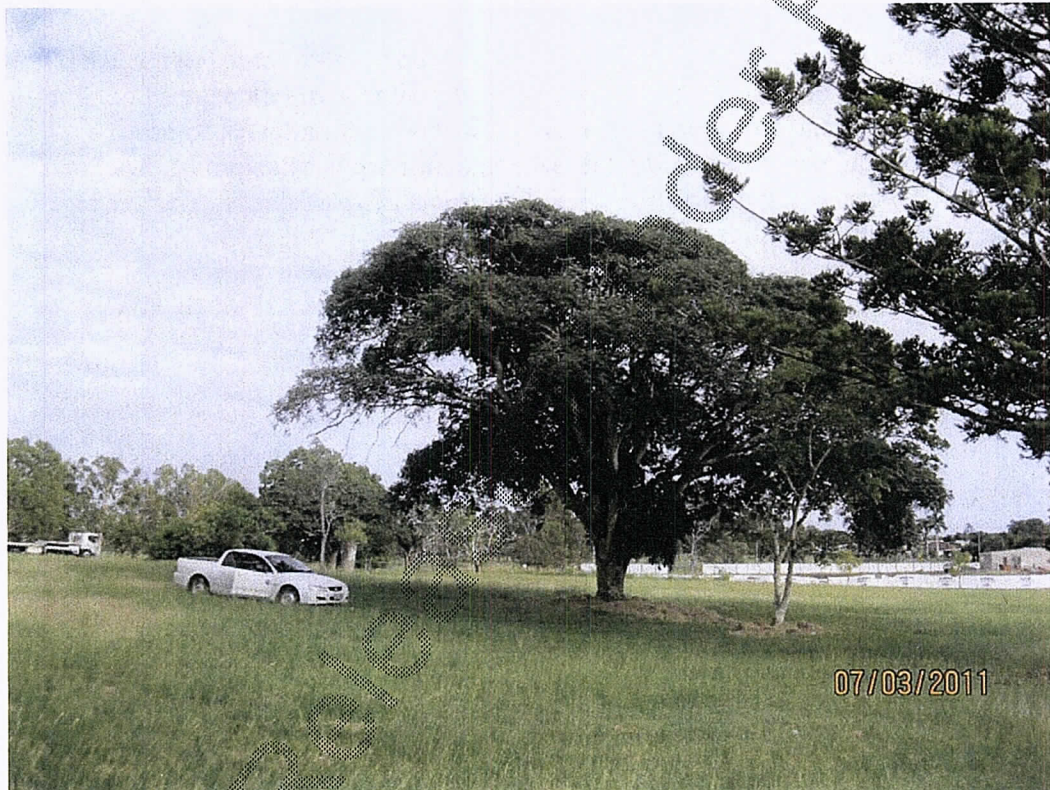
Tree 2. Albizzia lebbbeck- Indian siris tree, silk tree

This Albizzia tree is approximately 12m wide with an 18m spread with a DBH 1m. The tree although it has much dead wood and some diseased limbs is quite healthy. Careful removal of the deadwood and diseased limbs will enhance the tree's health and vigour.

This species can grow 18-30m tall with a spread of 30m or more. Care should be taken when placing buildings within the spread and drip line of the tree.

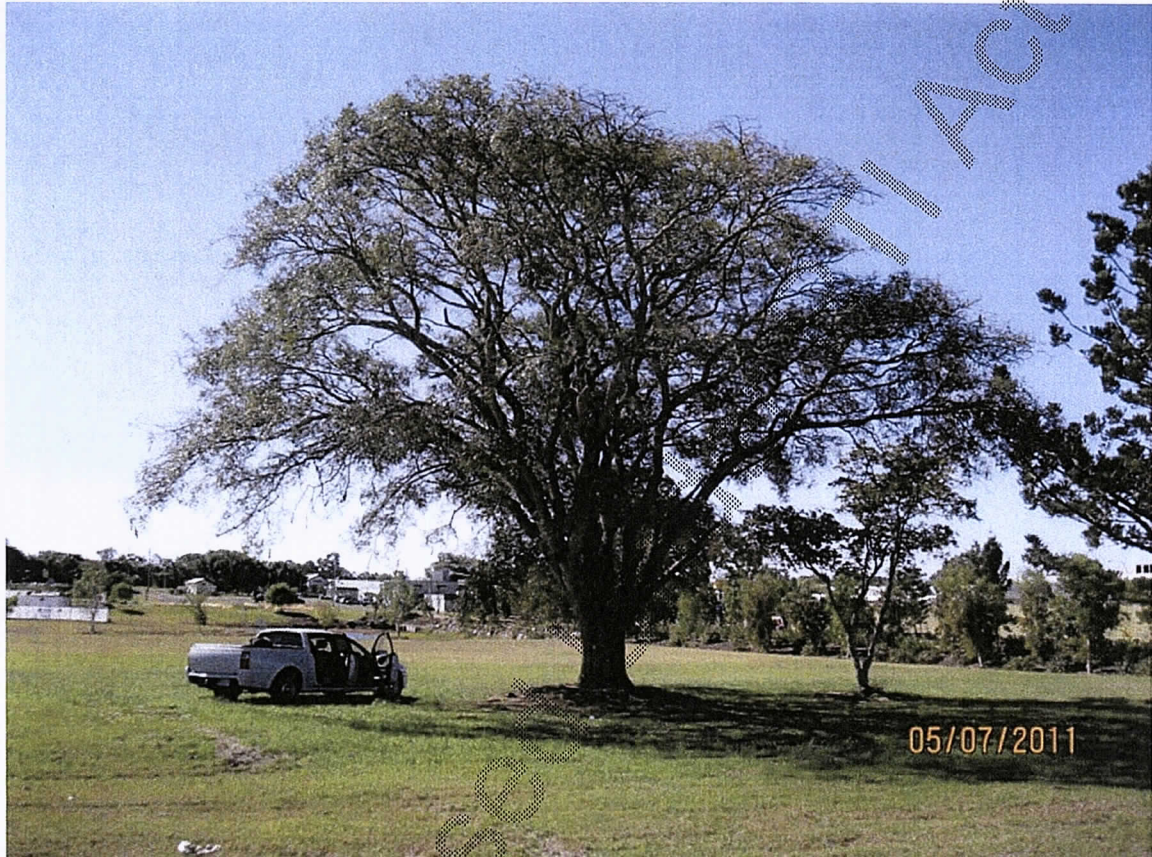
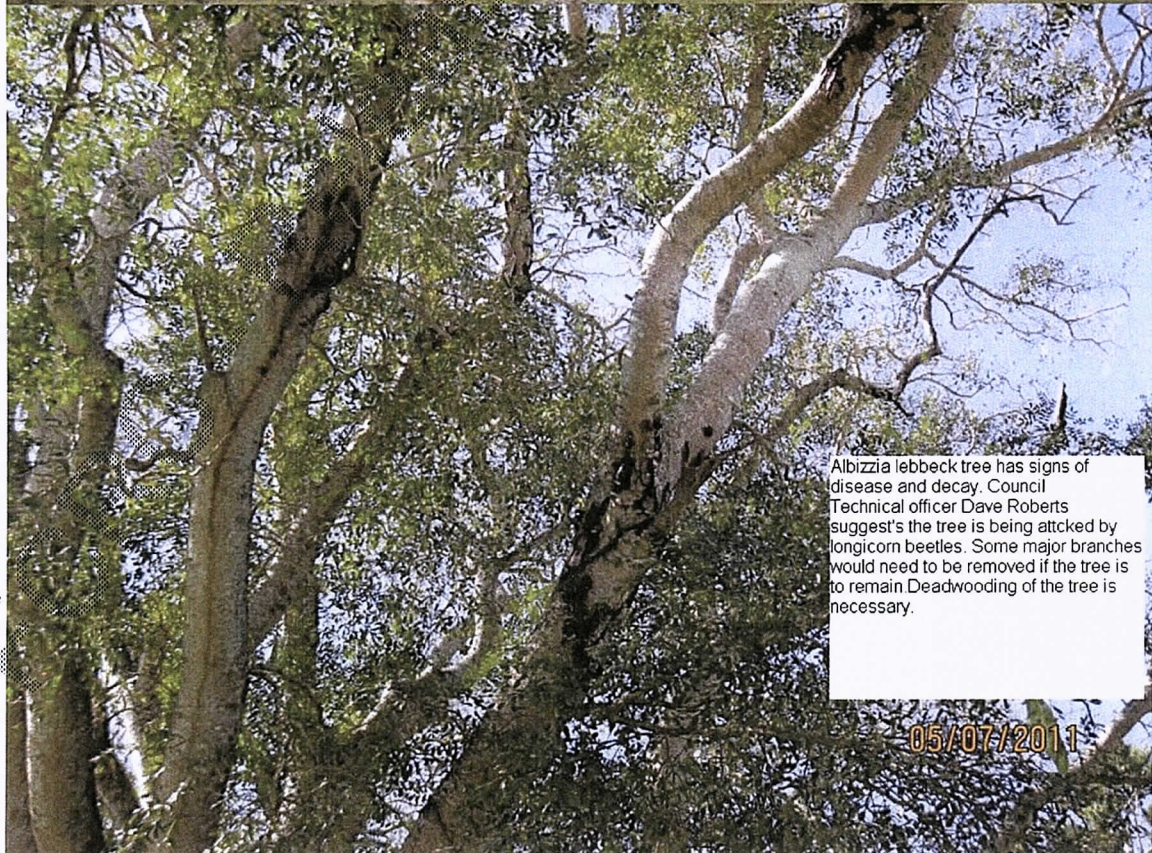
Albizzia lebbek tree has signs of disease and decay. Council Technical officer Dave Roberts suggest's the tree is being attacked by longicorn beetles. Some major branches would need to be removed if the tree is to remain. Deadwooding of the tree is necessary.

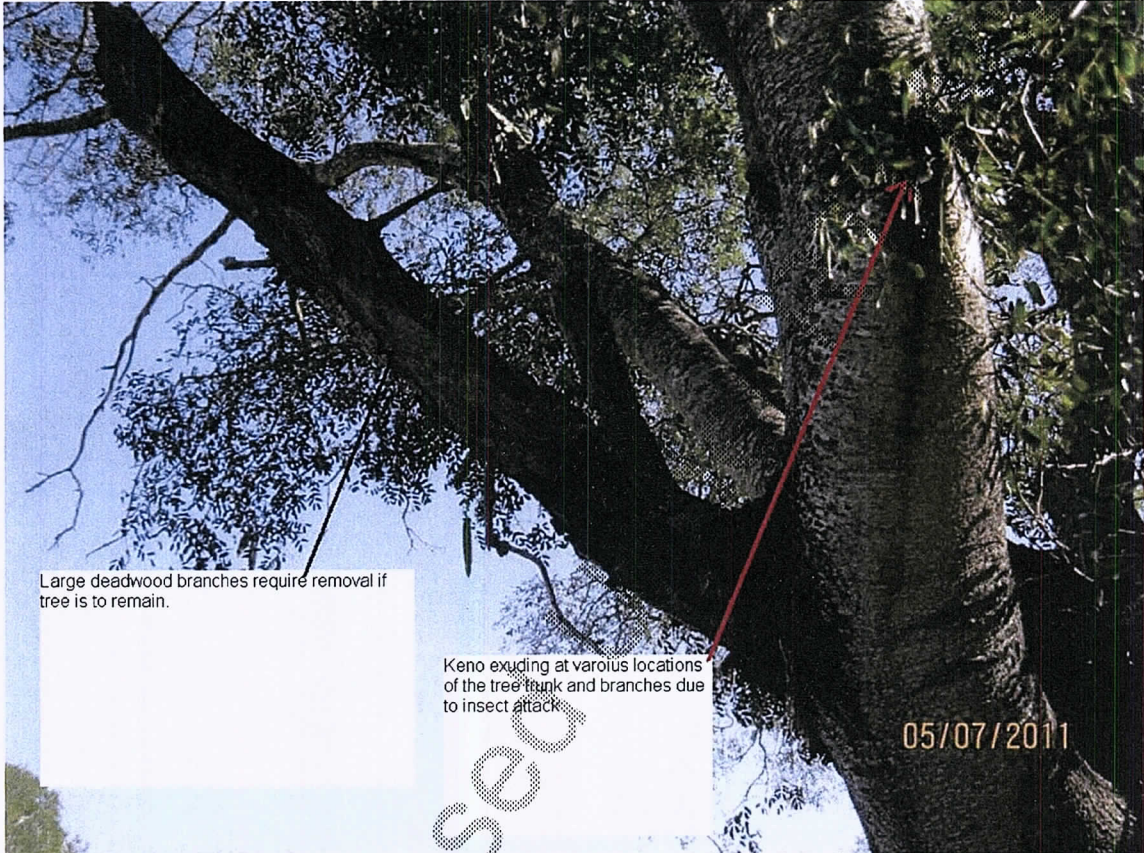
Large deadwood branches require removal if tree is to remain.

Keno exuding at various locations of the tree trunk and branches due to insect attack

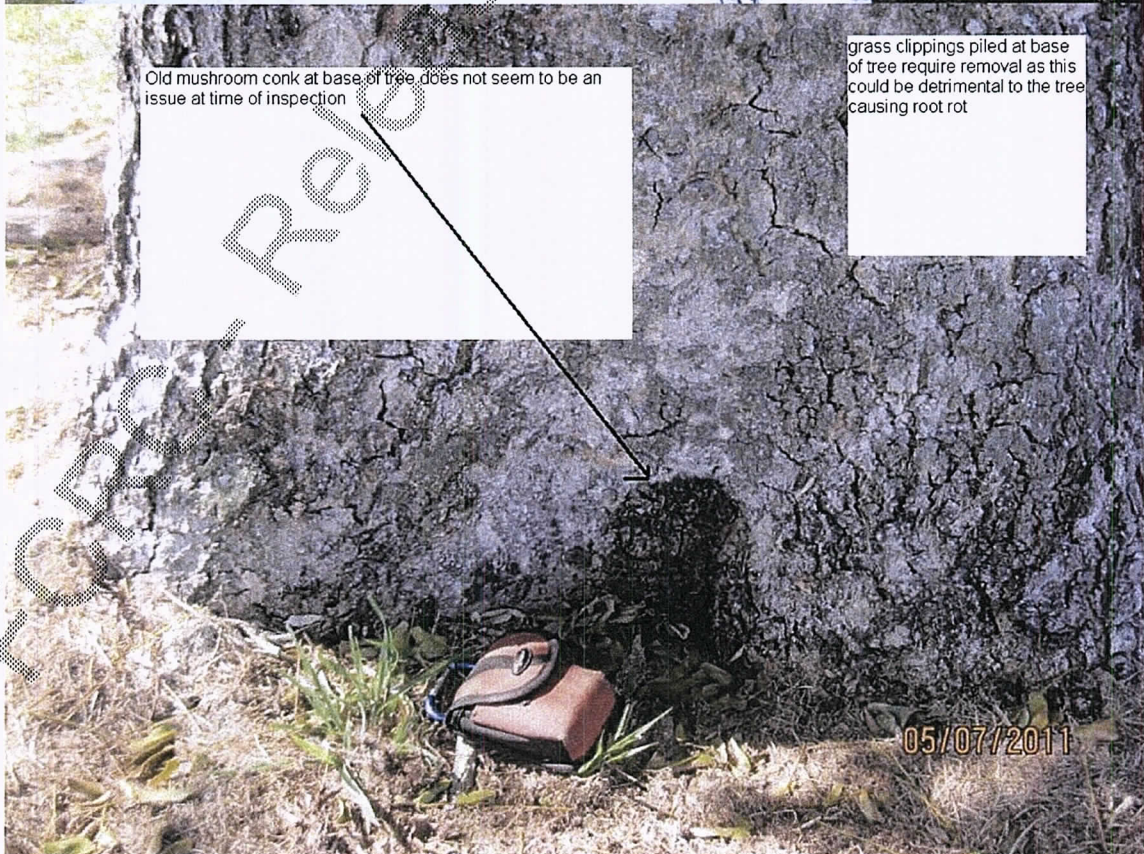
Old mushroom conk at base of tree does not seem to be an issue at time of inspection

grass clippings piled at base of tree require removal as this could be detrimental to the tree causing root rot

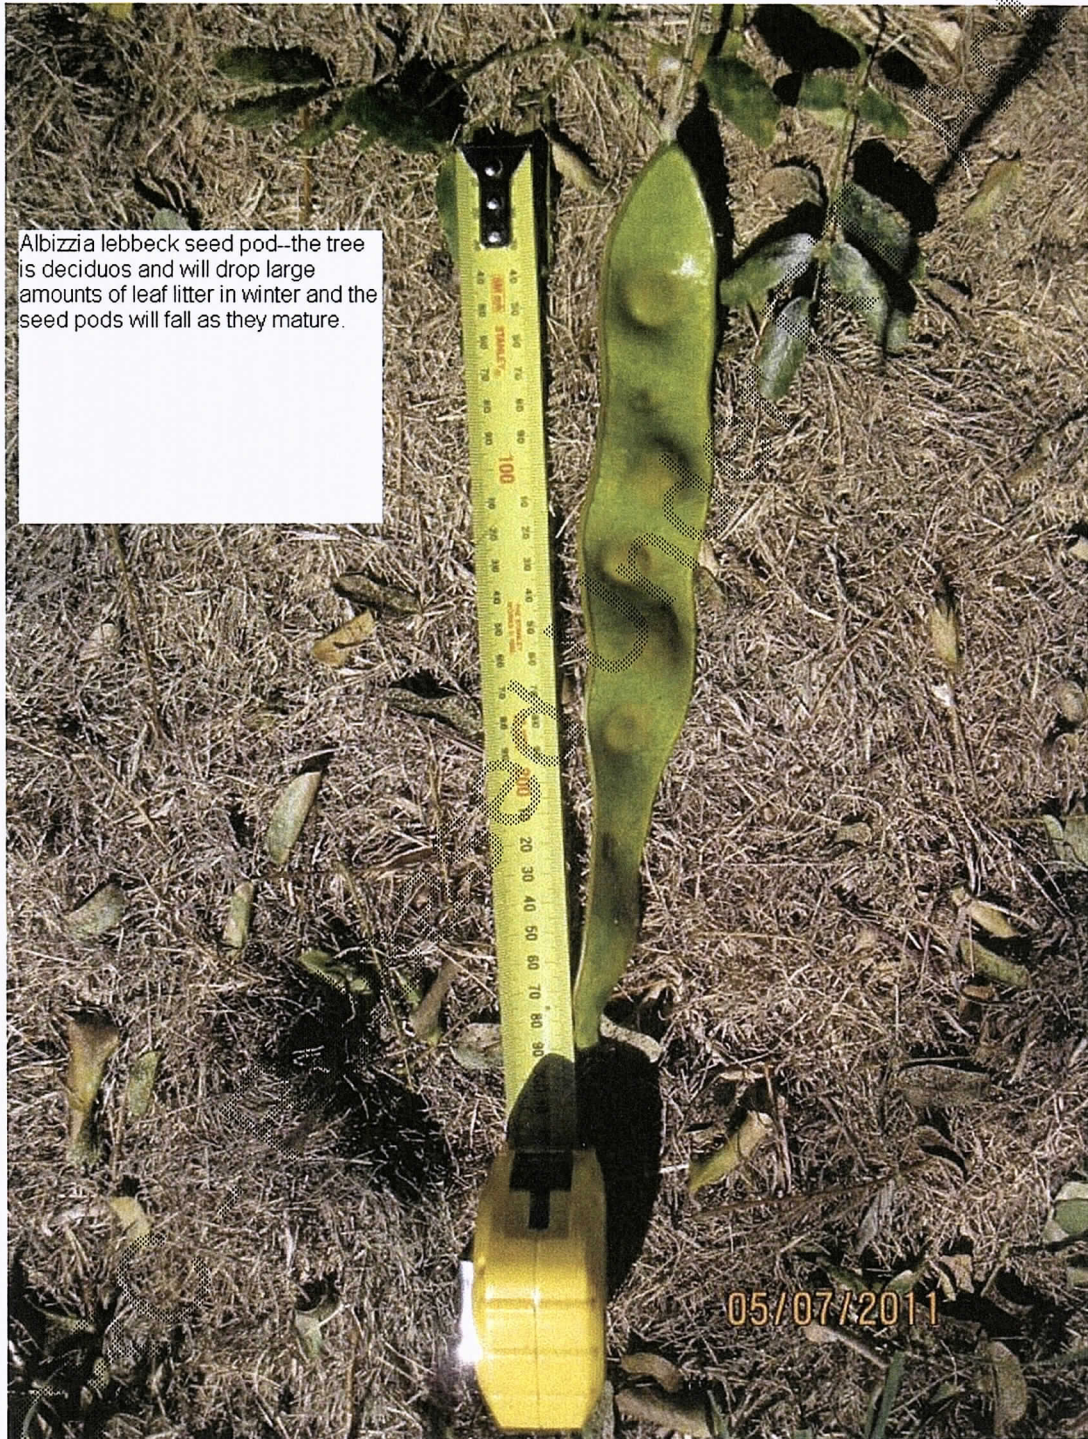
Albizzia lebeck seed pod--the tree is deciduous and will drop large amounts of leaf litter in winter and the seed pods will fall as they mature.

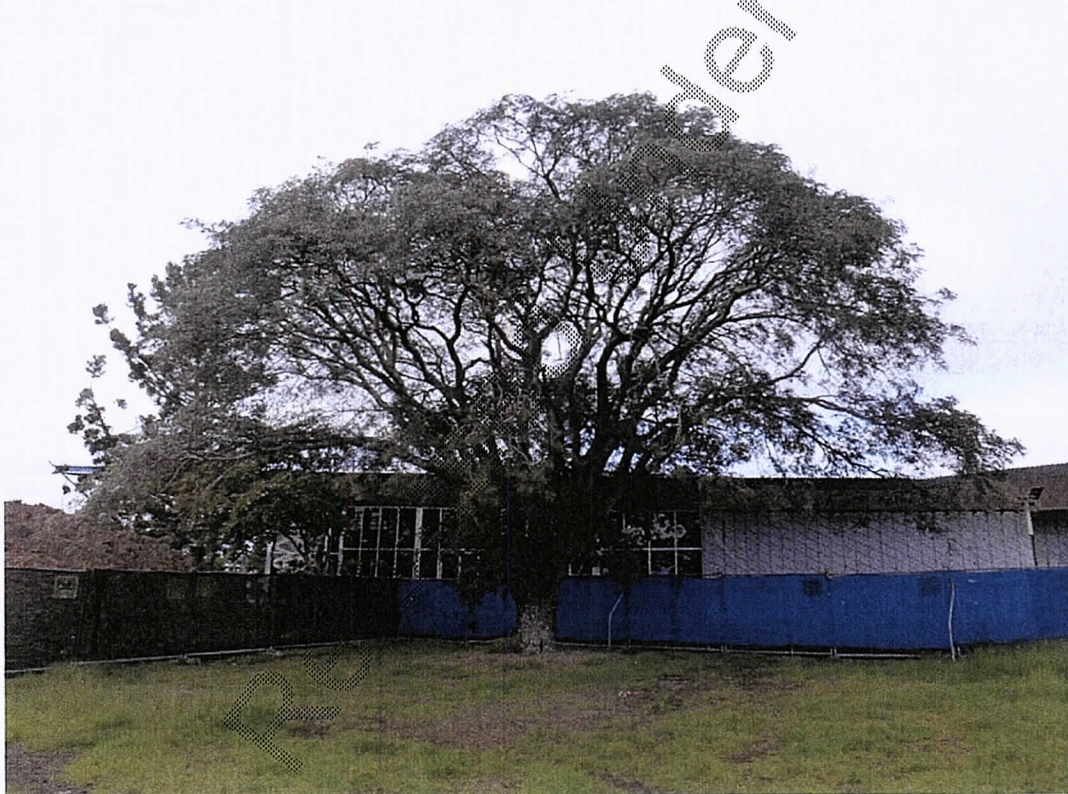
Tree displayed good form at trunk scaffold junctions

Tree displayed good root flare on tension and compression sides of tree trunk and visually no root exposure above the soil profile.

Tree displayed evidence of previous branch failures and dead stubs throughout canopy and at some locations displayed sap bleeding from wounds possible from borers.

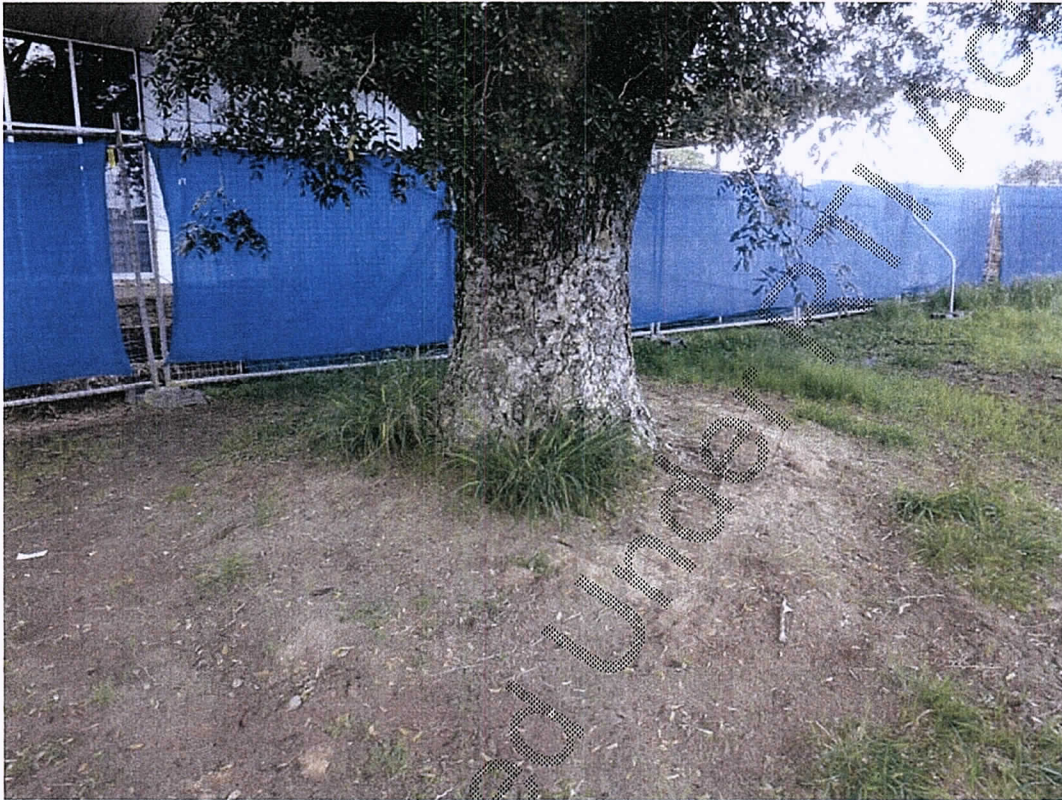
Tree displayed solid trunk

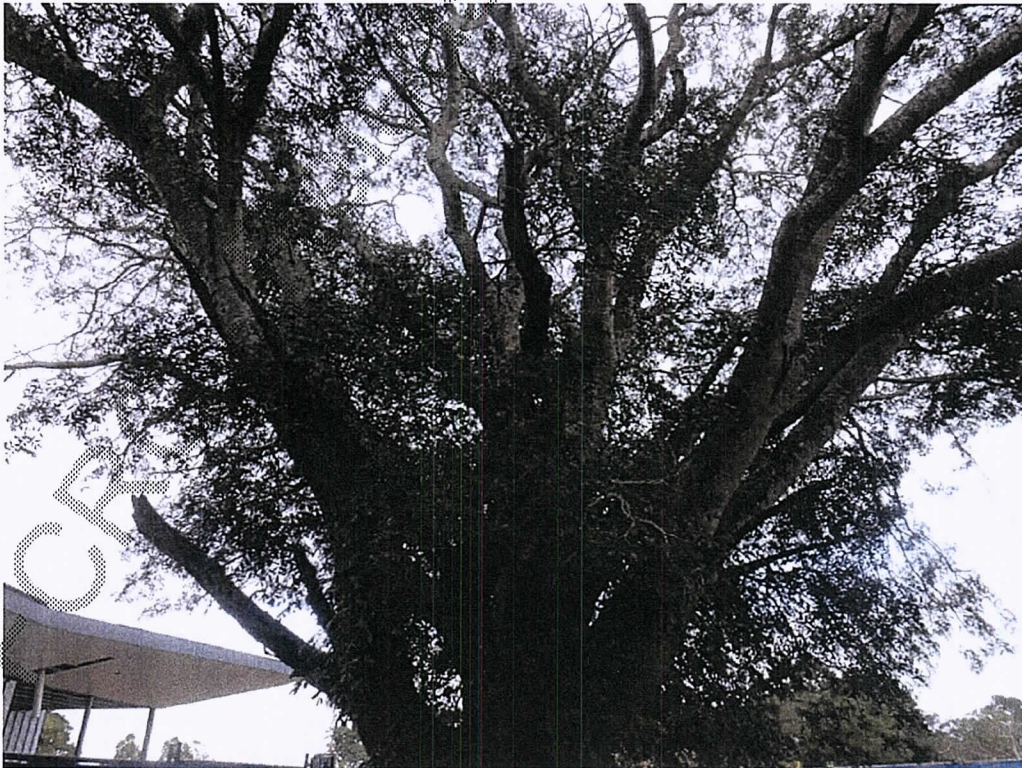
Tree Displaying deadwood throughout entire canopy
Tree displayed epicormic growth on lower part of canopy at branched scaffolds

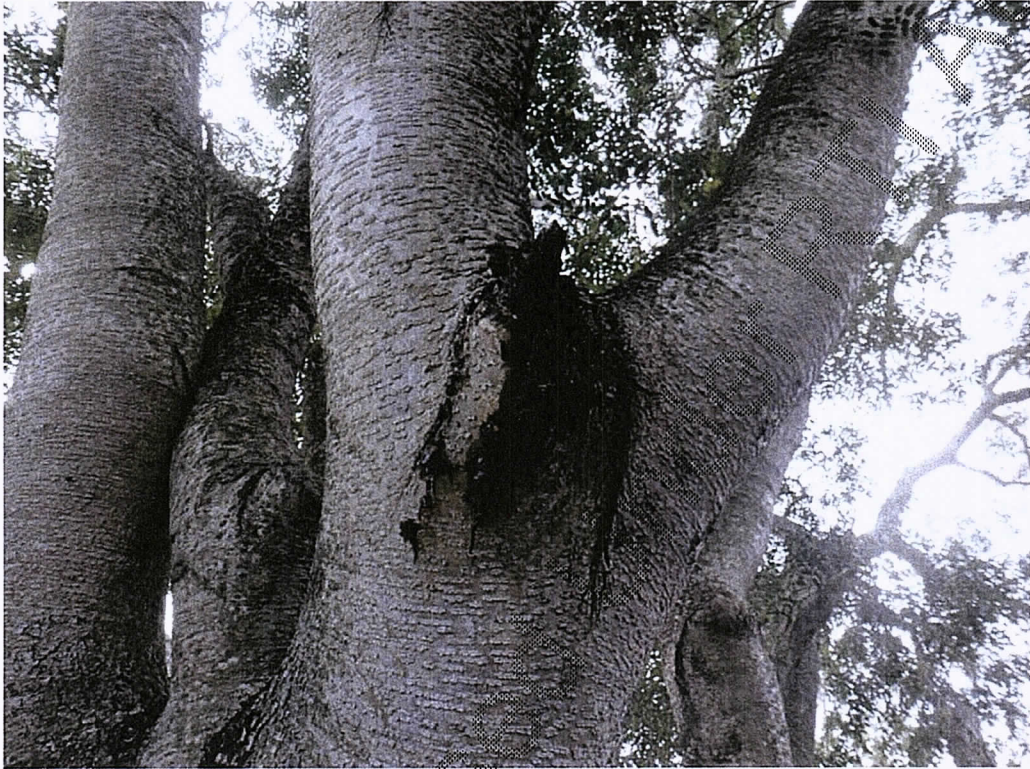
Evidence of suspect borer activity

- Aerial inspection to be undertaken to check timber integrity throughout entire canopy.
- The removal of all defective branches, deadwood and general pruning
- Under storage planting, mulching and land scaping from the trunk out to the drip line of the tree to alleviate root compaction and to isolate the area.
- Suitable species to be chosen for the under storage planting for compatibility and over all health of the tree.
- Strongly recommend **no** seating or structures paths etc. are erected or placed under the trees canopy.
- Place tree on a monitoring and maintenance program.

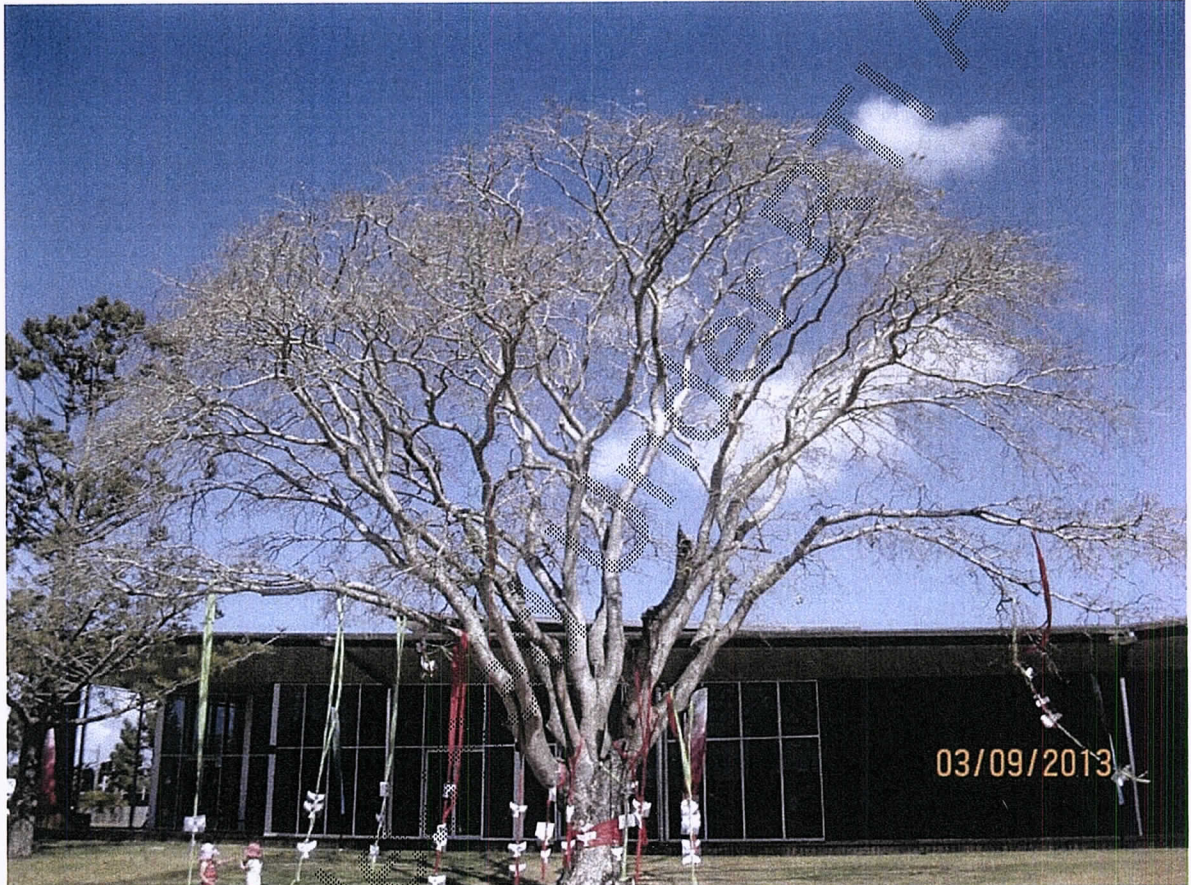
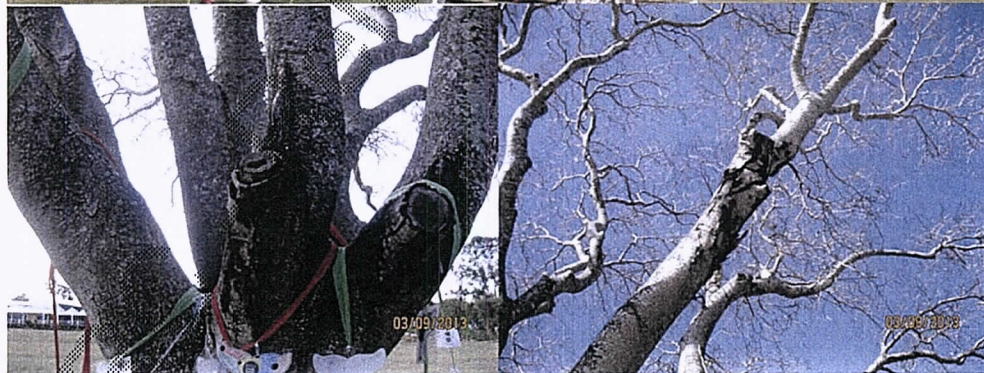
Both compression and tension sides of the tree trunk show good maturity. Despite having multiple leaders tree displayed good branch attachments and trunk unions.

Tree displayed some sap discharge/bleeding throughout the structure of the tree indicating that there is borer activity suspect (longicorn beetle).

Tree is showing signs of further decline since my last report. It is evident that deadwood and diseased branches due to borer activity has increased. Tree has had some significant previous limb failures throughout the canopy.

At some previous pruning locations and previous branch failing point's tree displayed poor wound wood development and appeared to be struggling to compartmentalize.

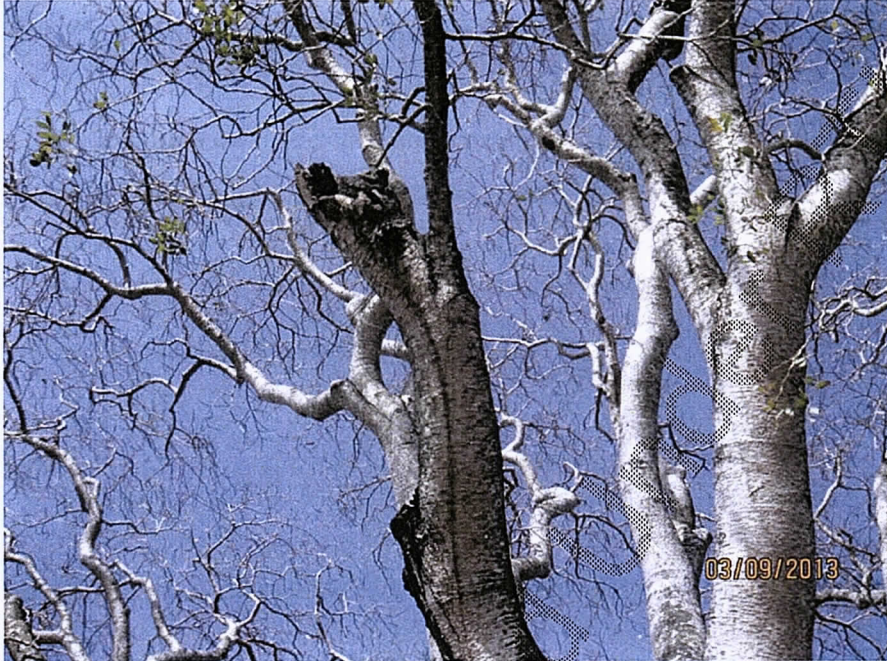
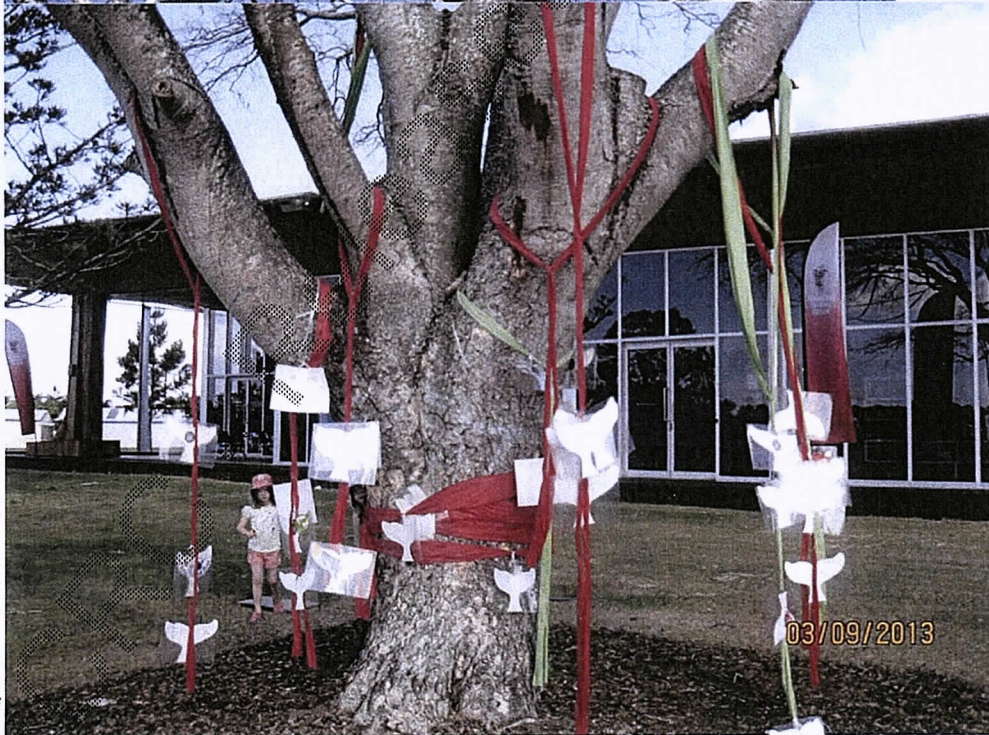
As to my previous report 22/06/12 Doc#2400059 and Inspection 03/09/13
Risk Mitigation: To retain this tree an exclusion Zone is required

(Recommendation) * To minimise hazard a post and rail fence alternatively sleeper edging needs to be installed around the tree. * This would need to extend out at least one to two metres past the drip line to restrict the use under the canopy/fall Zone.

*This would alleviate root compaction and has the potential to improve the trees health intern reduce the risk of the tree from failing and could extend the life of this tree.

IMPORTANT: If the recommendations put forward are not carried out, I strongly recommend the tree be REMOVED

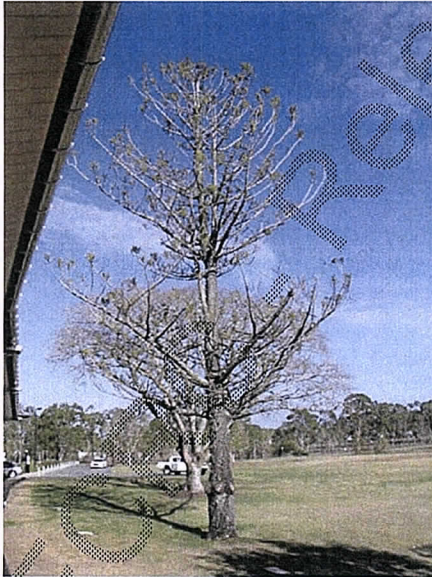
Spread: 8M Height: 12m DBH: 550mm

This tree is in decline. It is exhibiting poor leaf growth and wound wood development. The lower lateral branches have been removed 1.5m from base approx. 2 years ago. There are fungal fruiting bodies on 2 of these wounds suspected to be *Crepidotus nephrodes*- a common fungus found on dead wood.

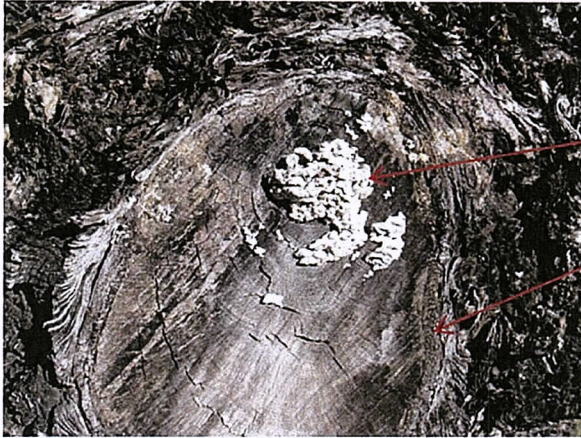
Fungal fruiting bodies and dysfunctional wood.
Poor wound occlusion also evident.

The change in grade and excavation around this tree has likely impacted upon the trees root system affecting the trees capacity to support vascular requirement. The tree exhibits no structural defects that would warrant removal but the prognosis is that the tree will continue to decline and eventually die.

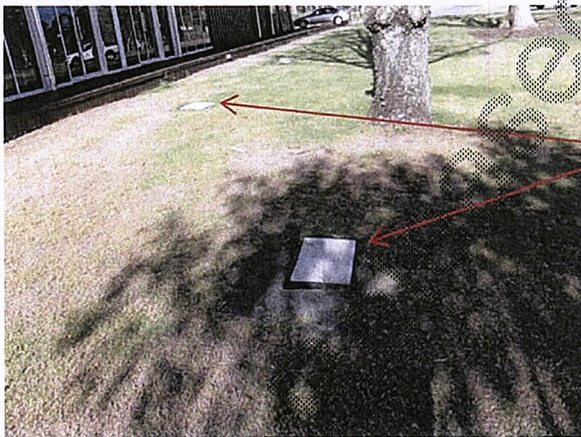
Installing electrical pits in close proximity to the tree would have caused significant root disturbance.

It is recommended that this tree be removed.

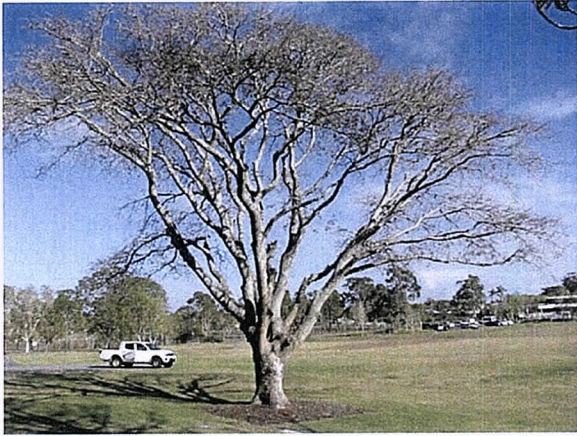
Spread: 18m Height: 9m DBH: 800mm

This tree contains deadwood within the tree canopy and "suspected" fungal fruiting bodies at the root crown. Excessive amounts of keno on the scaffold are indicative of insect/borer activity, cracks, splits or defects within the branch. The tree has poor leaf growth and existing leaves are smaller than normal.

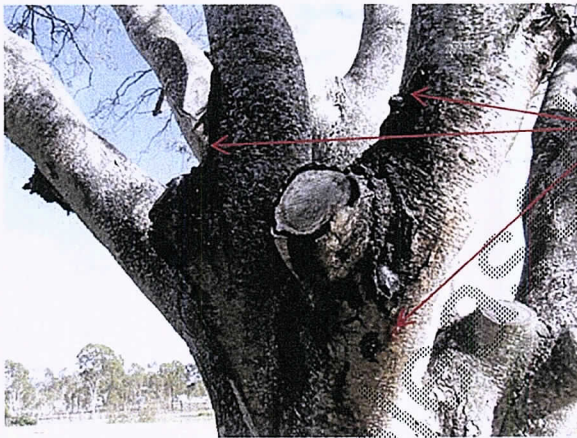
Peeling and cracked bark and large amount of keno (sap) are indications of insects and defects within the branch.

The tree has been stressed and declining in health since construction work occurred around the tree. Electrical and water pits are within 2m of the base of the tree. Installation of irrigation mains is likely to have negatively influenced the tree root zone.

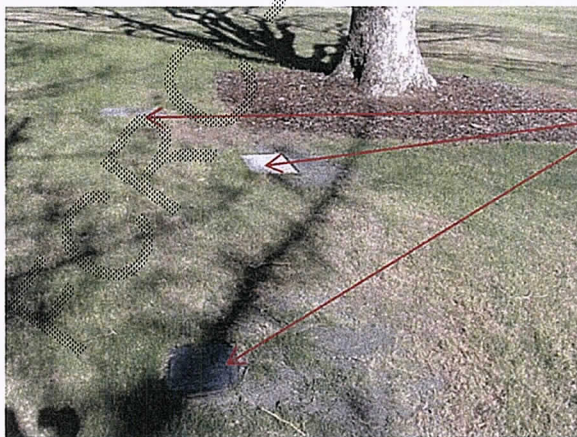
Proximity of underground infrastructure in relation to this tree

There is significant branch removal required to manage the risk associated with defective branches. This will result in further loss of stored carbohydrates, increase stress on the tree, change the shape and balance of the trees canopy and lead to further decline.

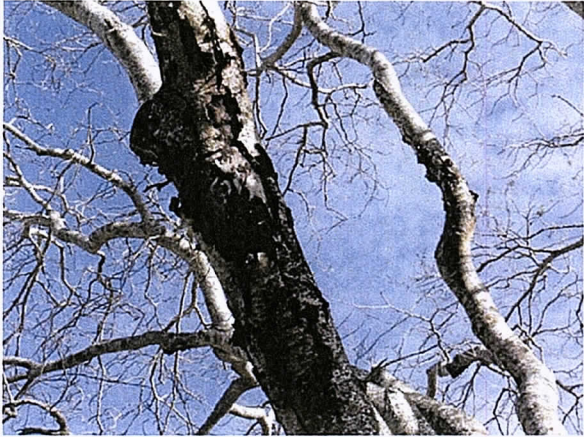
Evidence of further dysfunction within the canopy

Removal of this tree is recommended due to current risk presented by the tree and surrounding use patterns. This recommendation is also supported by the noticeable decline in tree health and the costly means required continuing to manage this tree.

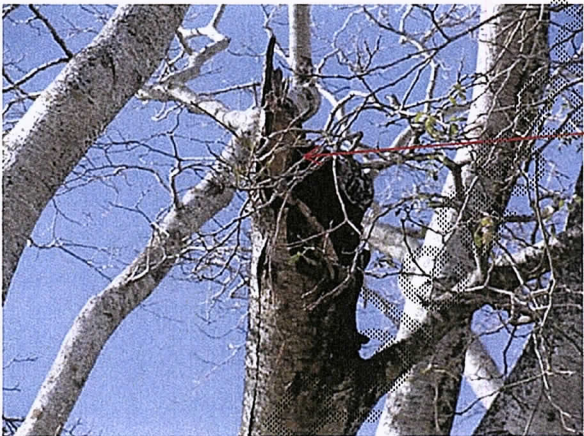
A point of previous branch failure.
