3 EROSION PRONE AREAS

3.1 Overview of Coastal Processes

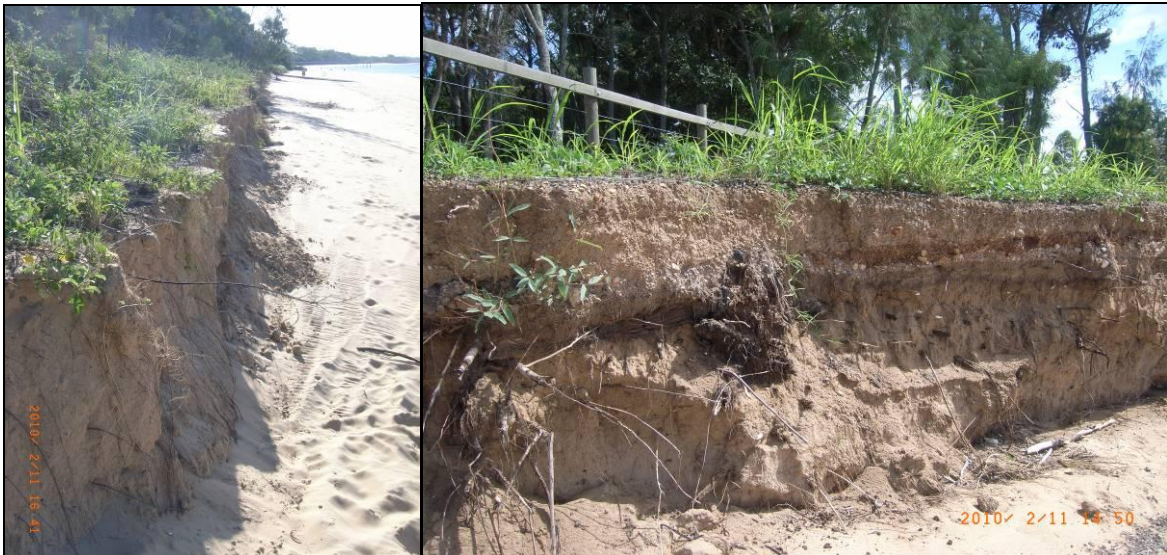
Figure 3.1: Erosion Scarp - Hervey Bay Area

Figures 3.1 shows two erosion scarps from the Hervey Bay area, approximately 0.8-1.0 m high. For the photo on the left, the full depth of the erosion scarp profile is comprised of sand, which shows that this location is an active beach environment where successive short term erosion events and beach re-building have occurred over time.

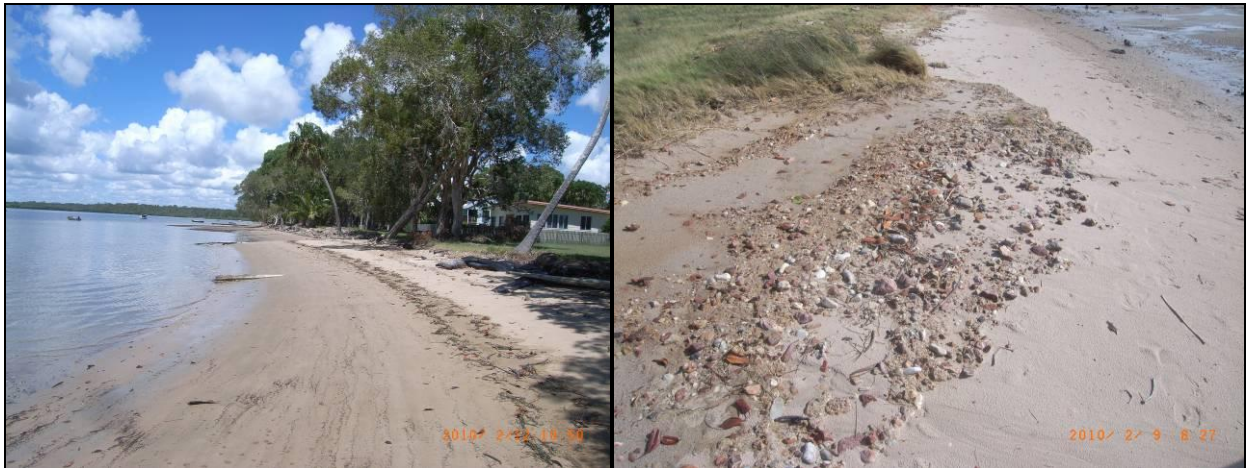
Figure 3.3: Erosion Scarp - Great Sandy Strait Area

The type of swell wave activity that is the major contributor to beach erosion and rebuilding in most locations rarely penetrates the Great Sandy Strait due to the sheltering effect of Fraser Island. Swell waves have a negligible impact on shoreline processes in this location and DEHP have categorised it as a tide dominated area. In the Great Sandy Strait short term erosion occurs when elevated water levels allow the tidal and wind driven currents to attack the upper beach face. The higher water levels that occur during king tides and storm tide events cause the slumping of the shoreline and this small amount of sand material is then transported off the beach face by tidal currents, leaving a small (approx. 20cm high) erosion scarp. Figure 3.3 shows the typical beach profile in the Great Sandy Strait area. The profile is not as steep due to the lack of swell wave action, and a low erosion scarp is present.

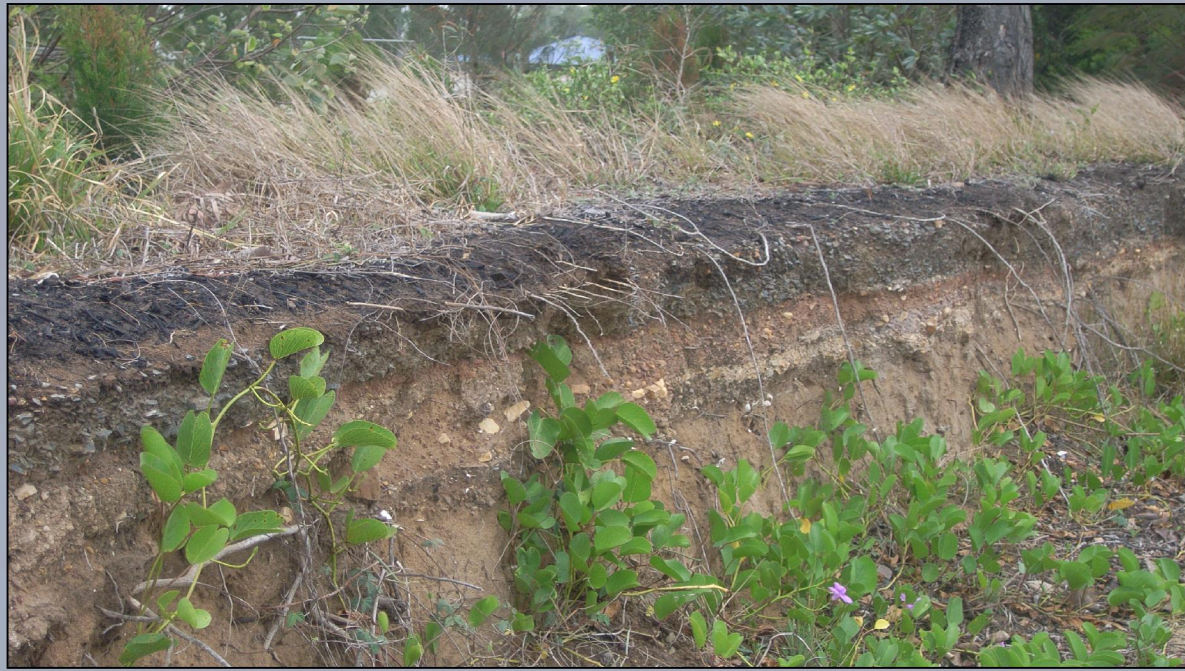
Some development in the Fraser Coast LGA has occurred within coastal areas that are vulnerable to storm erosion and long term recession, and in many cases this development represents substantial private and public investment. There are a number of locations in the study area where coastal development was established in locations that were at the time considered to be secure from shoreline erosion, but have subsequently been lost or damaged. Figure 3.4 shows a location affected by long term erosion. The cadastre shows that a road previously existed seaward of the current toe of dune line and the accompanying photograph shows evidence of road base in the erosion scarp.

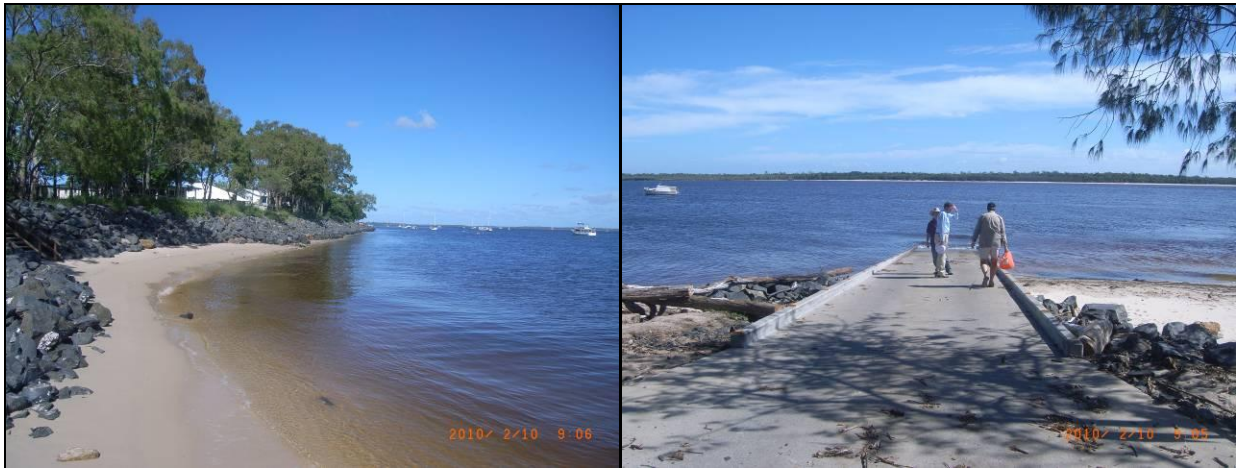
Figure 3.5: Existing Coastal Protection Works - Burrum Heads

- A rock seawall in three sections, running from the western end of the Lions Memorial Park to Dudley Street (Figure 3.5, left);
- Two boat ramps, one located at the end of Ross Street and one at the end of Burrum Heads Road. The boat ramps are located in between seawall sections and act as groynes (Figure 3.5, right); and
- What is referred to as a "drainage groyne", located at the end of Dudley Street at the terminal end of the rock seawall.

The 320 m long seawall section west of the Ross Street boat ramp is described as being in generally reasonable condition, although the local rock material used to construct the wall is deteriorating and there is some evidence of collapse (Coastal Engineering Solutions, 1999). The portion of the rock seawall west of the Burrum Heads Road boat ramp was described as being subject to failure due to inadequate toe protection (Coastal Engineering Solutions, 1999). The seawall section east of the Burrum Heads Road boat ramp is in better condition.

There is also a 320 m long seawall west of the Ross Street boat ramp that protects the Lions Memorial Park. It is comprised of flexible concrete matting that is in relatively good condition, however, the local rock used in construction tends to fracture and this can affect the integrity of the seawall (Coastal Engineering Solutions, 1999). On the day of the site inspection (10/02/2010) sections of the seawall were being undermined.

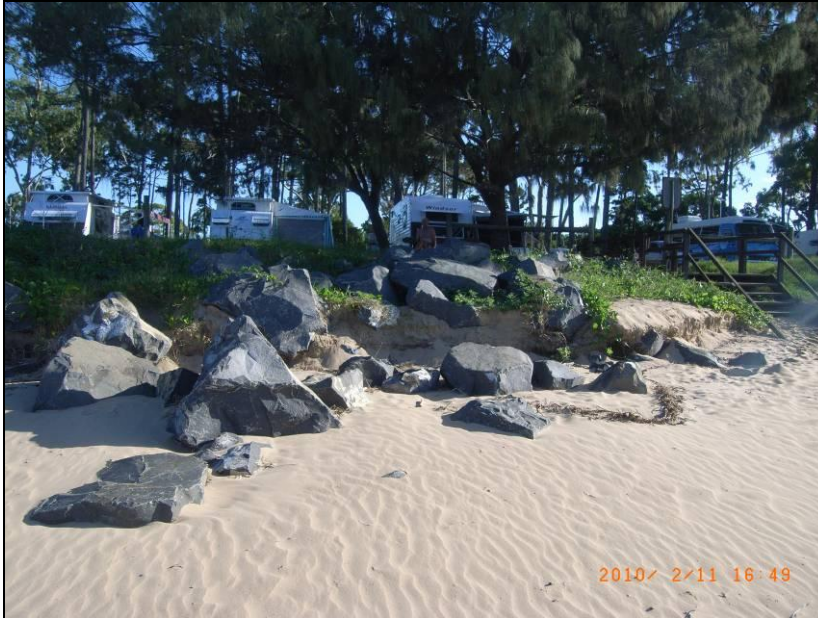
Figure 3.6 Existing Coastal Protection Works - Scarness

There is a rock seawall in Scarness that runs along the shoreline parallel to The Esplanade. West of the Scarness Jetty, the seawall is in poor condition, with most of wall having failed through a combination of undermining at the toe and dislodgement of rocks off the armoured slope (Coastal Engineering Solutions, 1999).

At the time of the condition assessment in 1999, it was noted that ad hoc repairs appeared to have been undertaken with no evidence of an engineered rehabilitation of the seawall. That section of the rock seawall east of the Scarness Jetty was said to be in good condition in 1999 (Coastal Engineering Solutions, 1999), although based on the site inspection undertaken (10/02/2011) it appears that some sections are subject to failure (Figure 3.6).

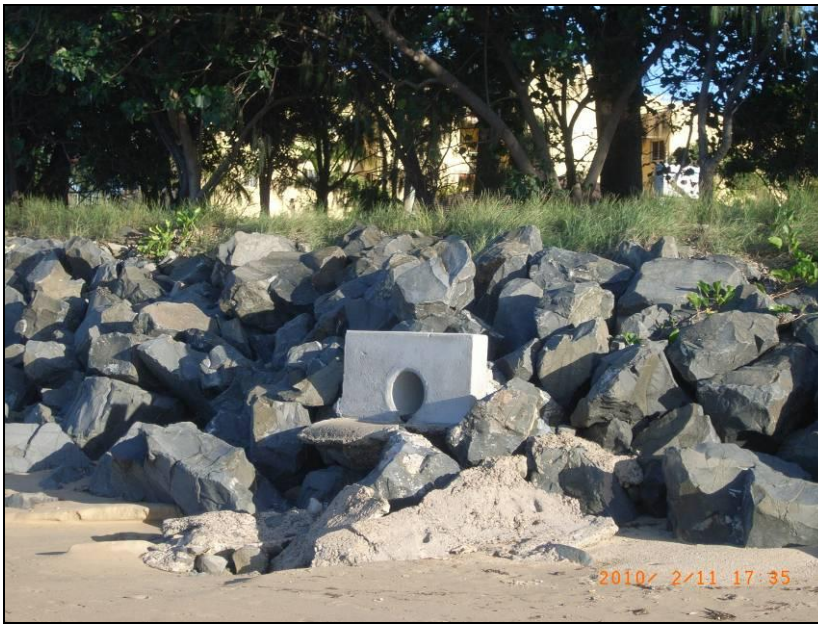
Figure 3.7: Existing Coastal Protection Works – Urangan

In Urangan the foreshore is protected by rock seawalls running from Robert Street to the Urangan Pier, and two rock groynes located at the end of Margaret and Churchill Streets. Opposite Elizabeth Street there is a section of seawall in the form of a stepped revetment, however, there is no information available on the condition of this structure and this discussion focuses on the rock seawalls. At the time of the 1999 condition assessment by Coastal Engineering Solutions, the rock seawall sections between the Pier and Churchill Street were in very poor condition in places due to degradation of the rock material. The Esplanade area and the beach south of Urangan Pier have also experienced some significant erosion, and this has been a cause of concern to the community. Some deterioration of the seawall sections along Shelley Beach was evident on the day of the site inspection (10/02/2011; Figure 3.7).

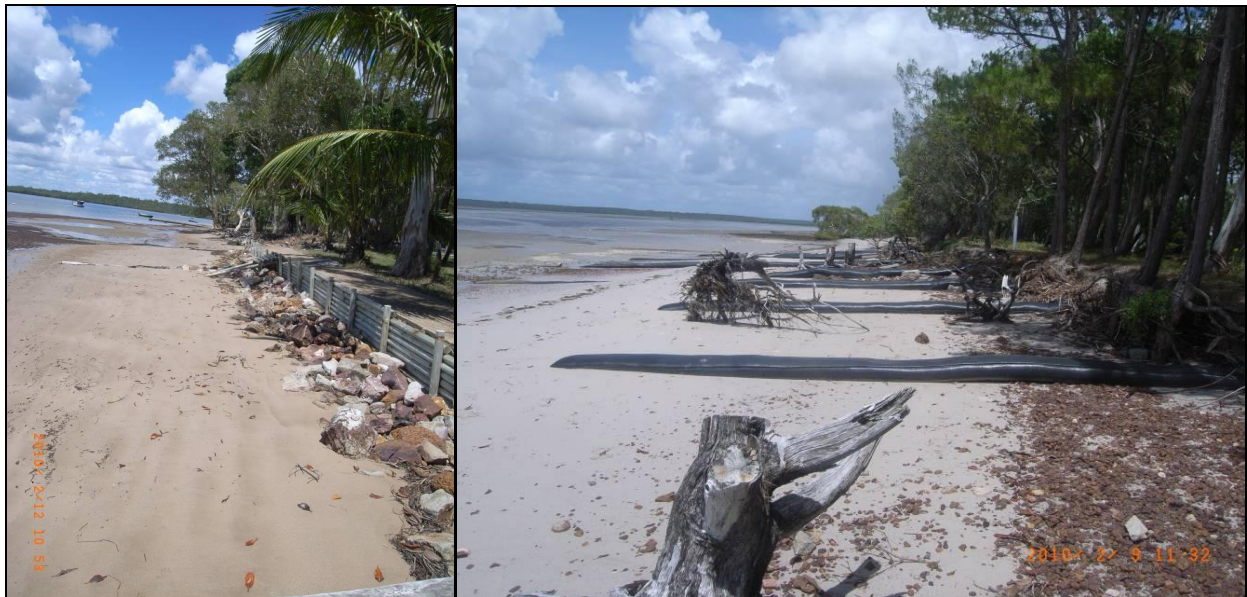
Figure 3.8: Existing Coastal Protection Works – Great Sandy Strait

- Rock seawalls and sloping revetments for a small number of freehold properties at various locations along the coastline;
- A seawall at the ferry terminal at River Heads;
- A failing seawall comprised of rock and concrete at Boonooroo; and
- Poor condition rock seawalls in Poona.

A number of less formal coastal protection works have also been implemented, particularly at Poona. They appear ad hoc in nature and it is not known if they were undertaken by FCRC or residents. These informal works consist of retaining walls of timber construction, low rock seawalls, and groynes constructed from sand filled geotextile bags or pieces of timber. It is anticipated that most of these types of works would likely have limited success in arresting shoreline erosion, and it is reasonable to assume that they would not provide much protection (particularly from overtopping) during a storm event or cyclone.

Some examples of the existing coastal protections works are shown in Figure 3.8.
