MORTUARY CHAPEL, MARYBOROUGH CEMETERY CONSERVATION MANAGEMENT PLAN

MORTUARY CHAPEL
MARYBOROUGH CEMETERY
WALKER STREET
MARYBOROUGH

Prepared for Fraser Coast Regional Council
Funded by the Queensland Heritage Grant Program
December 2010

Final report

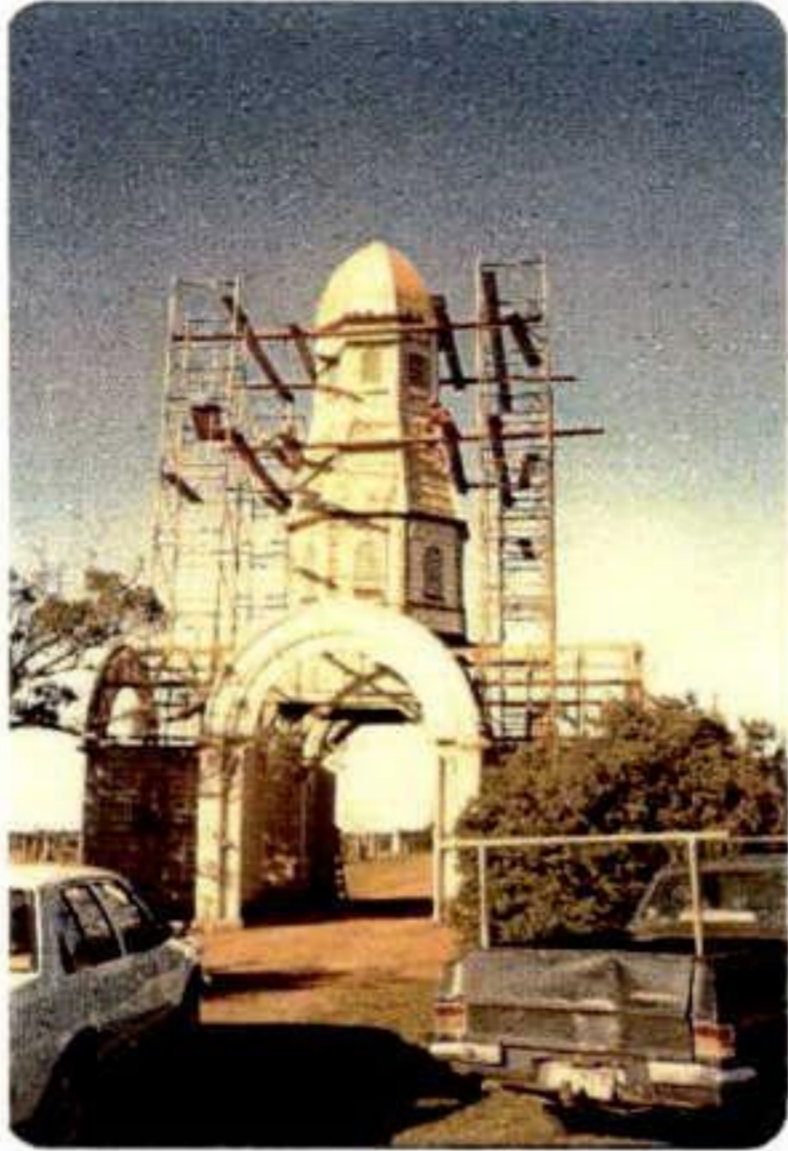
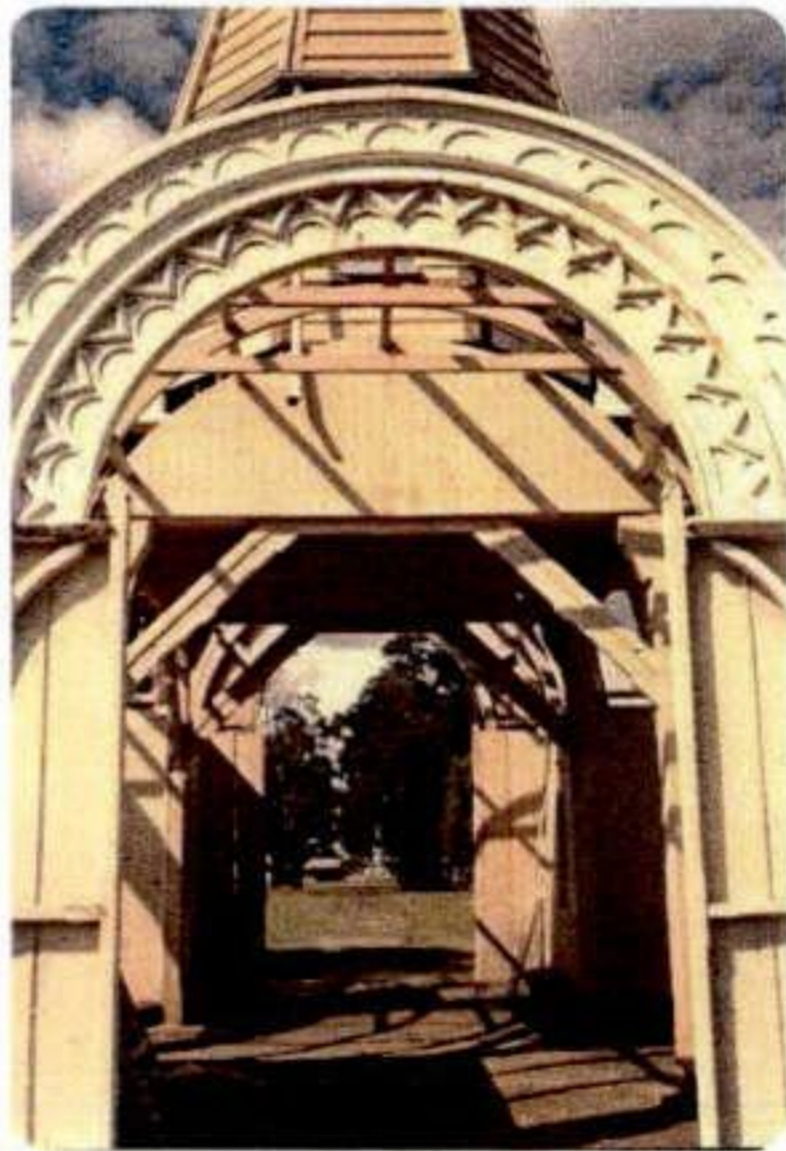
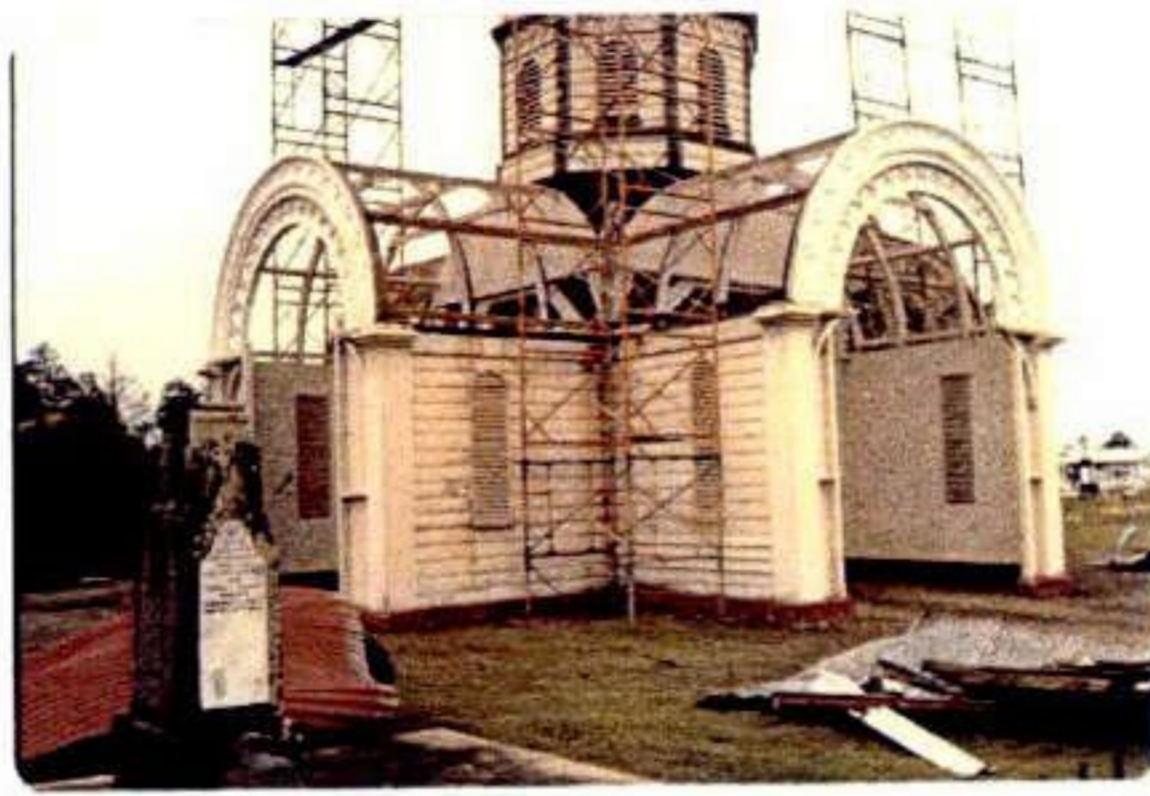
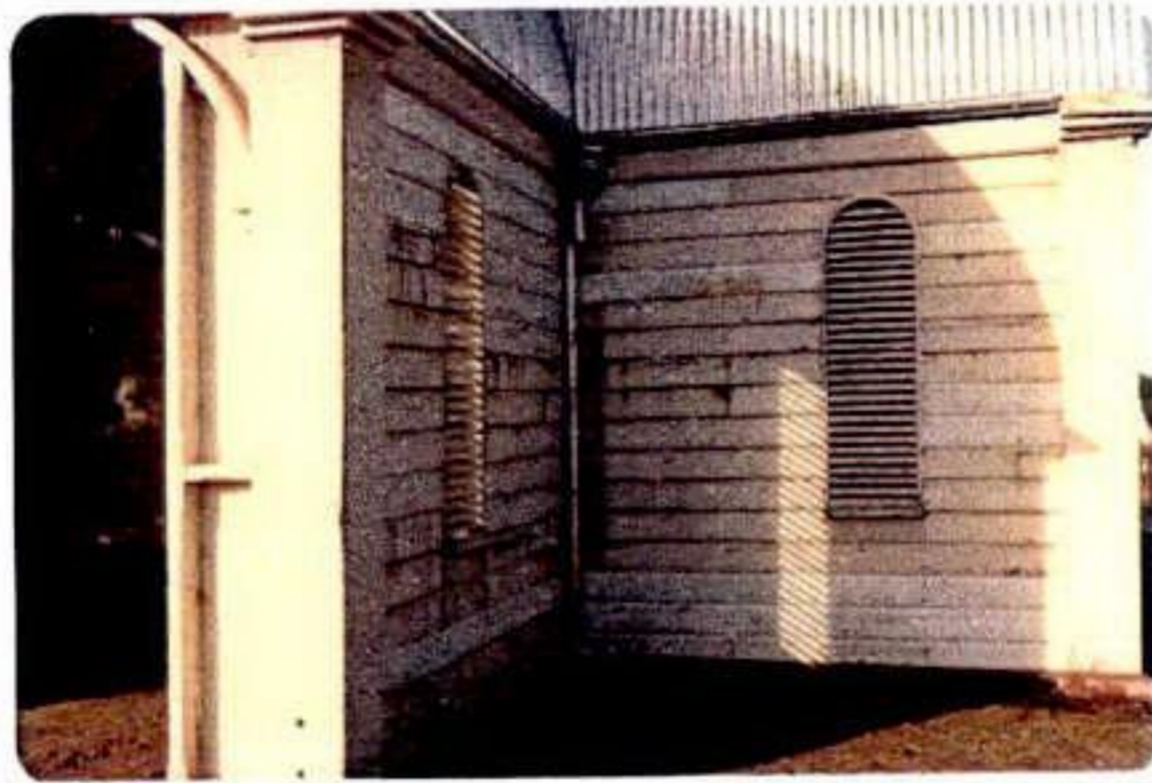
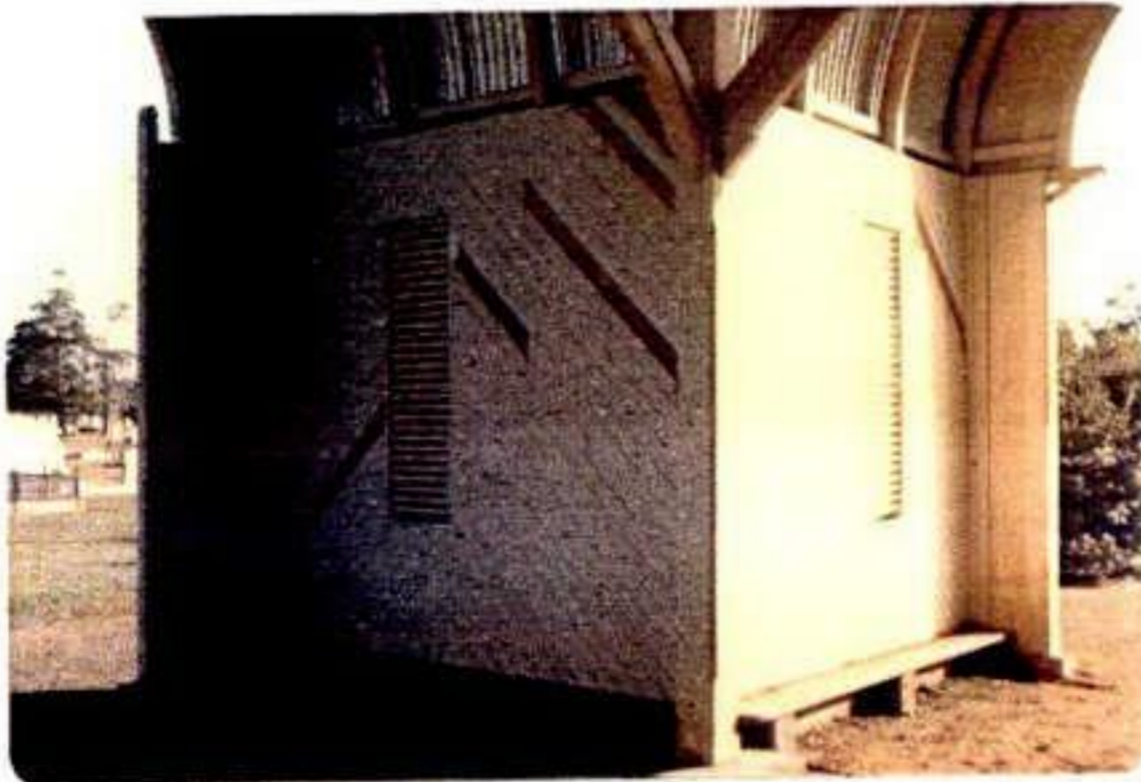
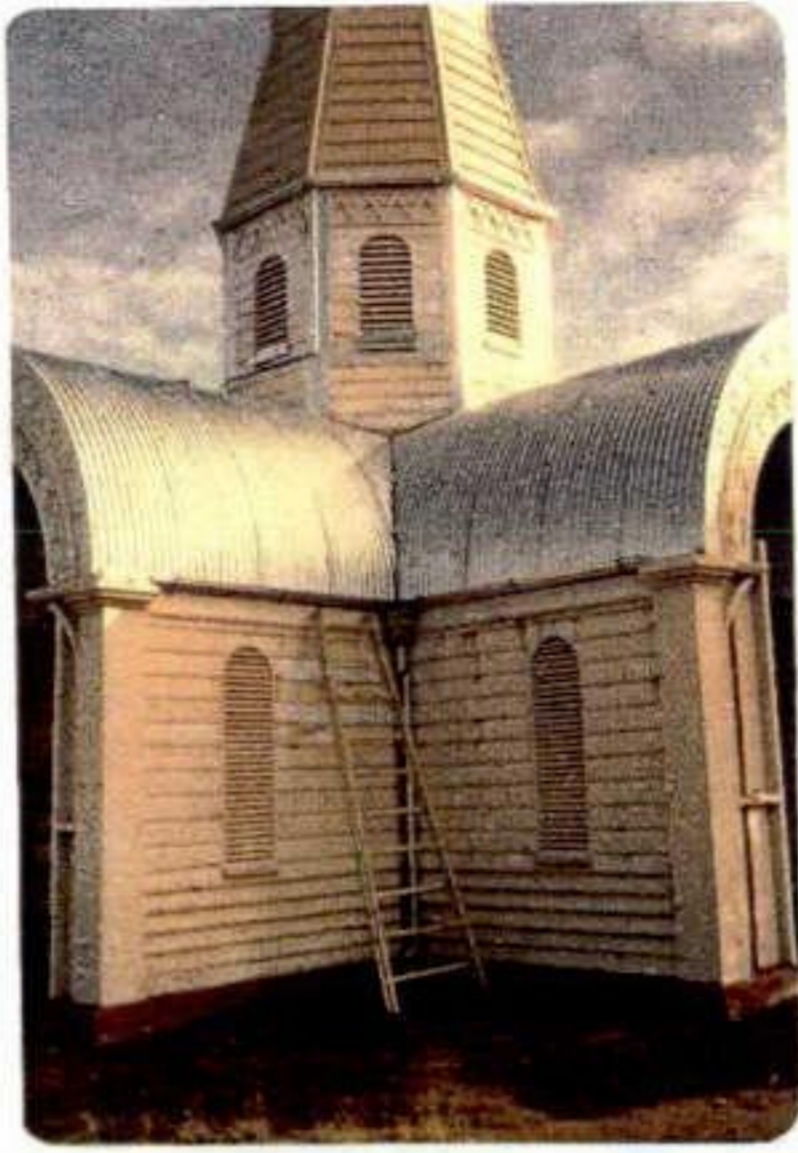
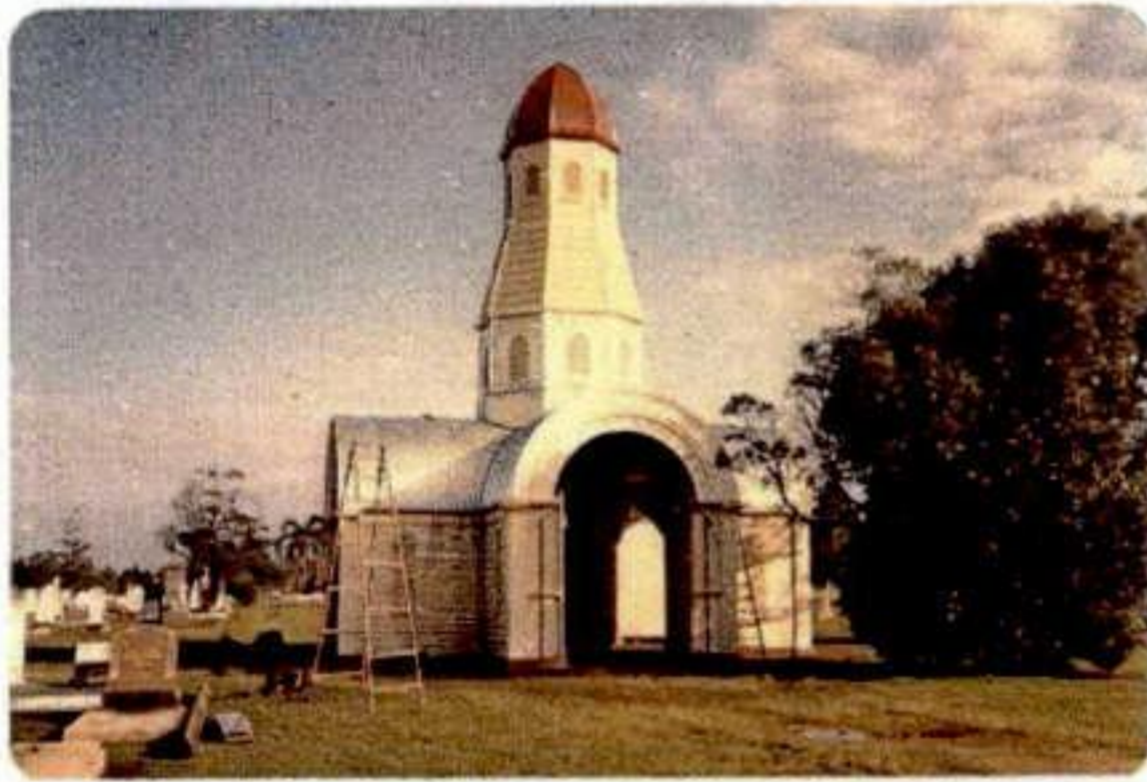
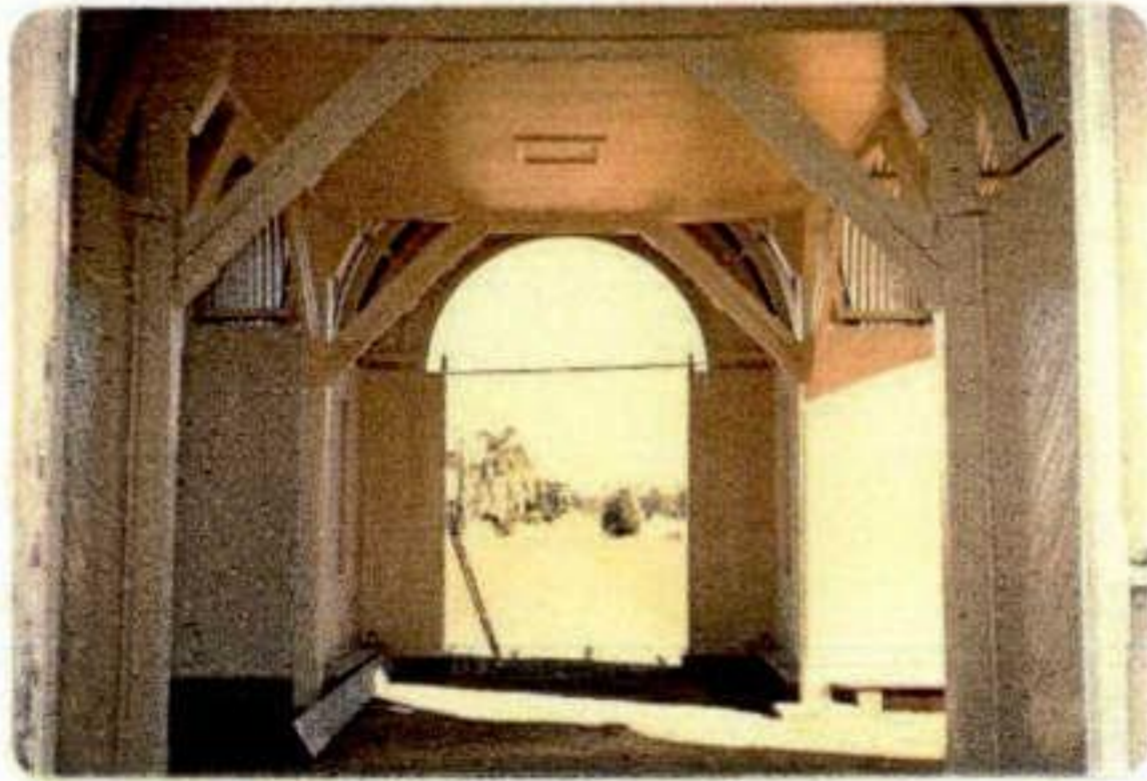
PHOTOGRAPH INDEX

1. Roofing removed, new dome frame complete.
2. Transepts without roofing, deteriorated purlins exposed.
3. Transepts without roofing, tower without flashings.
4. New External cladding, and new guttering, heads and downpipes.
5. New internal lining, and new window sills.
6. New roofing, and new tower flashings.
7. Structure painting underway.
8. Interior painting underway, including new tower ceiling.

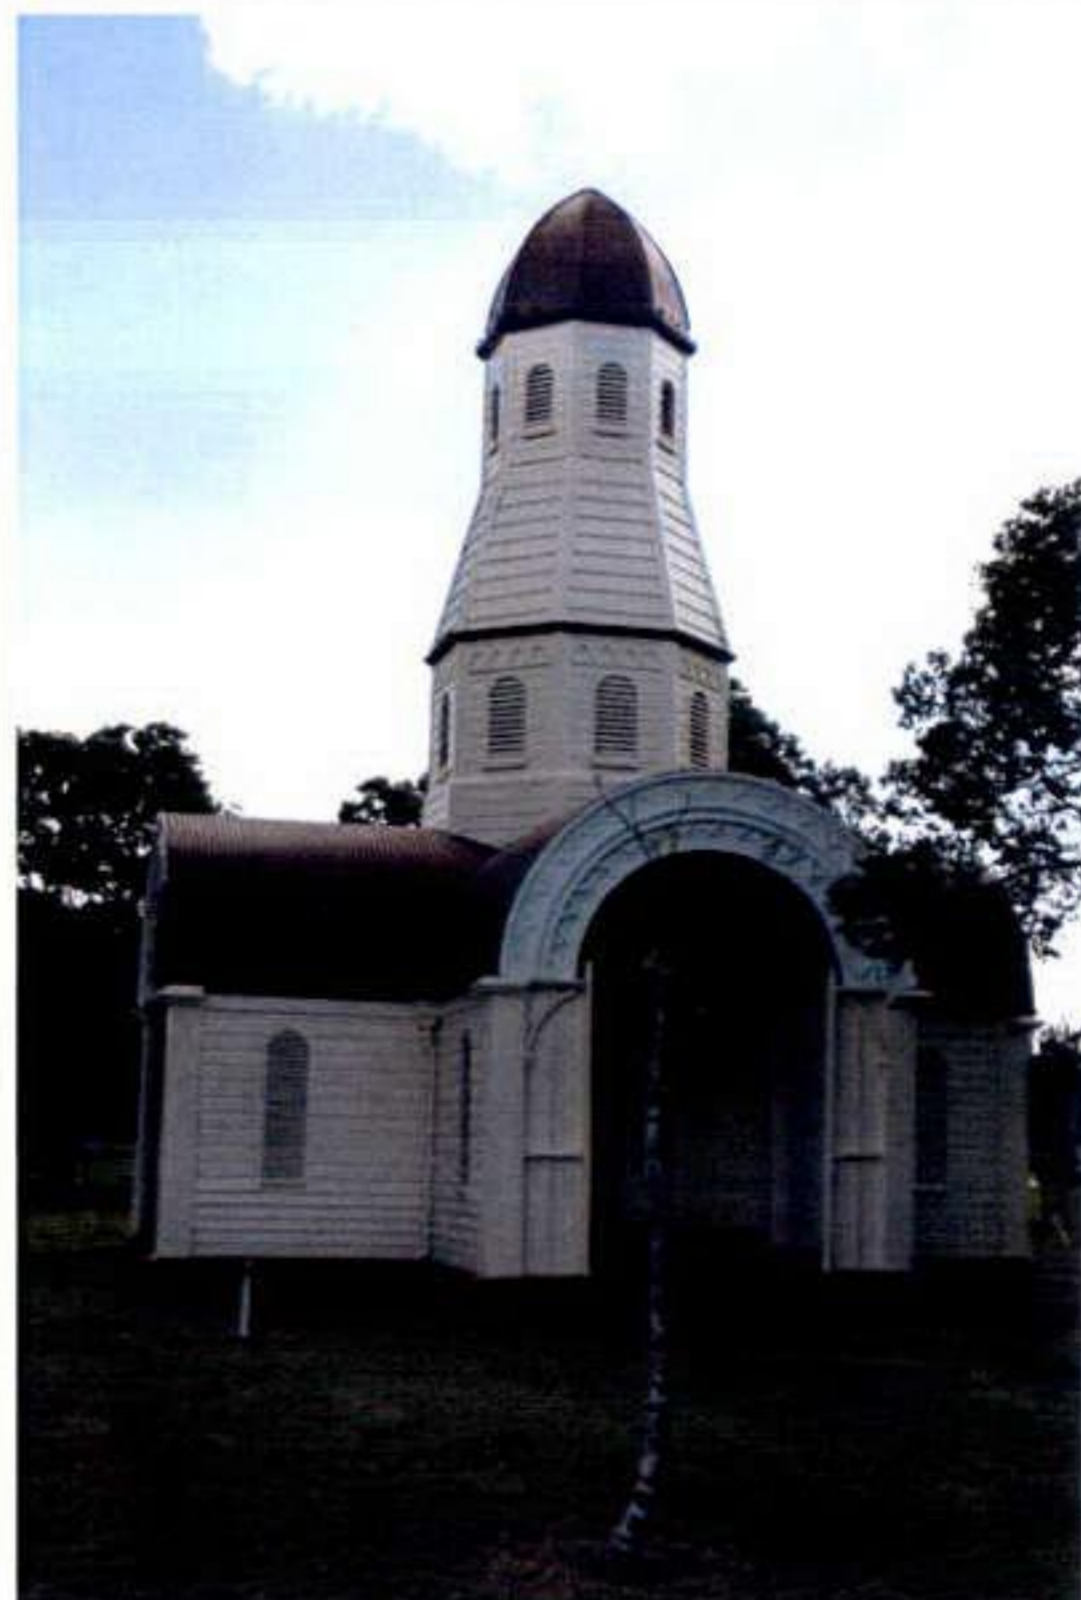
03 East/west axis showing the western elevation of

chapel.

Note the weatherboards to the lower part of the wall in place of the chamfer boards. This work was done prior to the 1983 restoration.

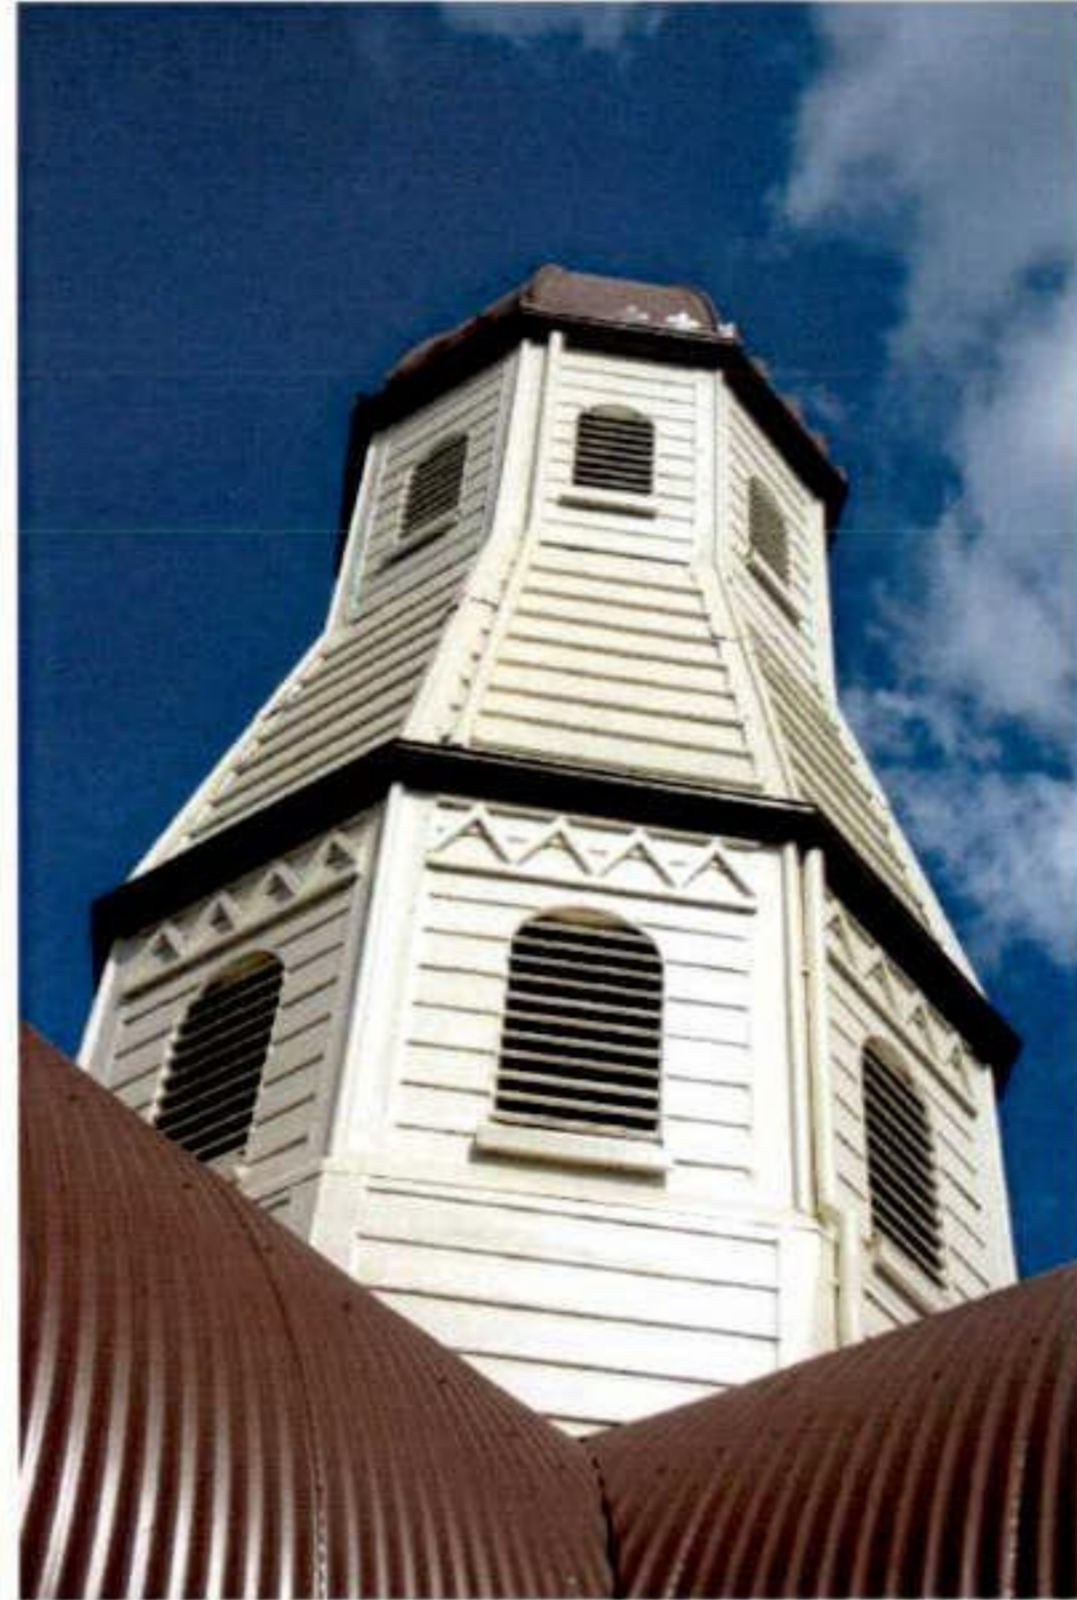
05 Fleche (tower) view. Much of the chapel's external fabric was repaired or replaced during the 1983 chapel restoration.

Note the two discreetly laid narrow diameter downpipes shedding water from the fleche.

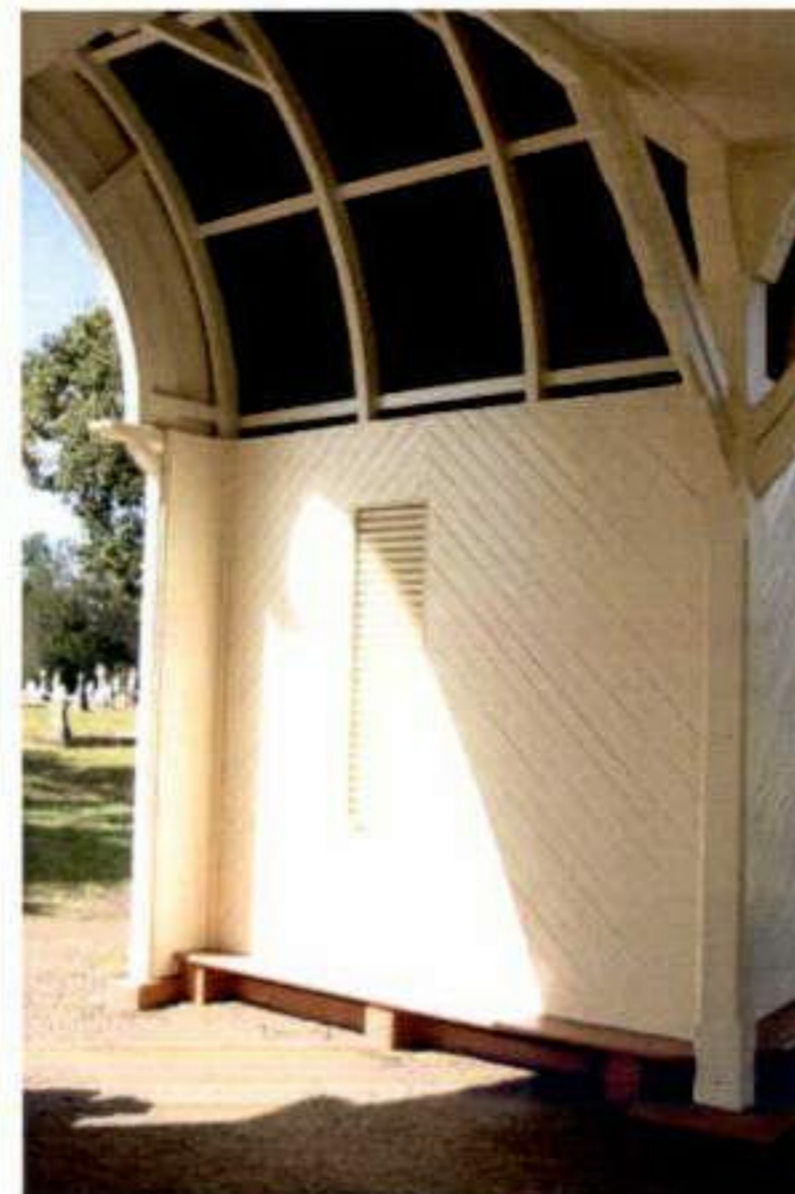
07 Typical interior view of the chapel. The interior was restored with replacement of damaged and missing building fabric during the 1983 chapel restoration.

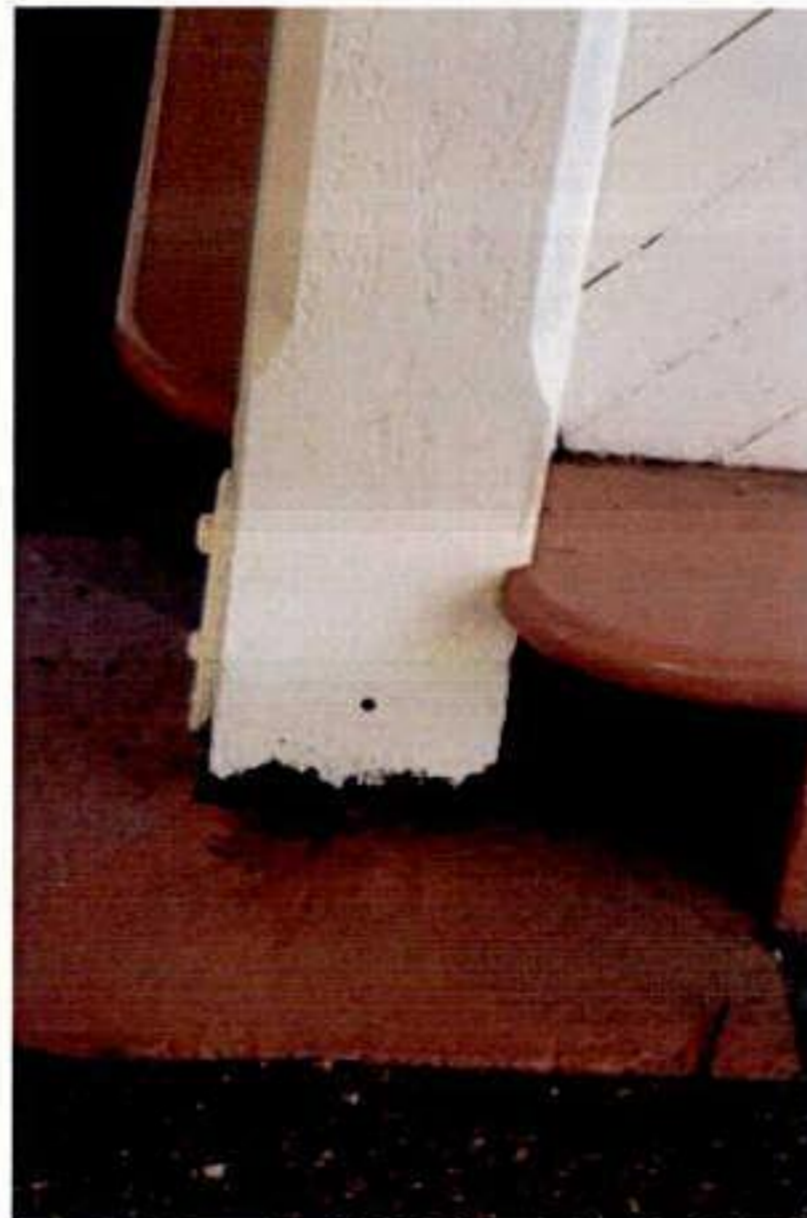
11 Detail view of a post supporting the fleche (tower) above.

The posts attachment to the ground appears to have been altered a few times, probably to try to deter water damage and rot. Wrought iron shoes were introduced but later covered by a concrete plinth which was compensating for the raised ground level. This post still shows signs of weather damage due to its close proximity to the ground.
