General Assessment of 2 Trees on the proposed Cultural Centre Site adjacent Library on Old Maryborough Road, Hervey Bay.
By Paul McDermott

TREE HAZARD EVALUATION FORM

Tree Hazard Evaluation Assessment- Albizia and Norfolk Island pine at Discovery Sphere

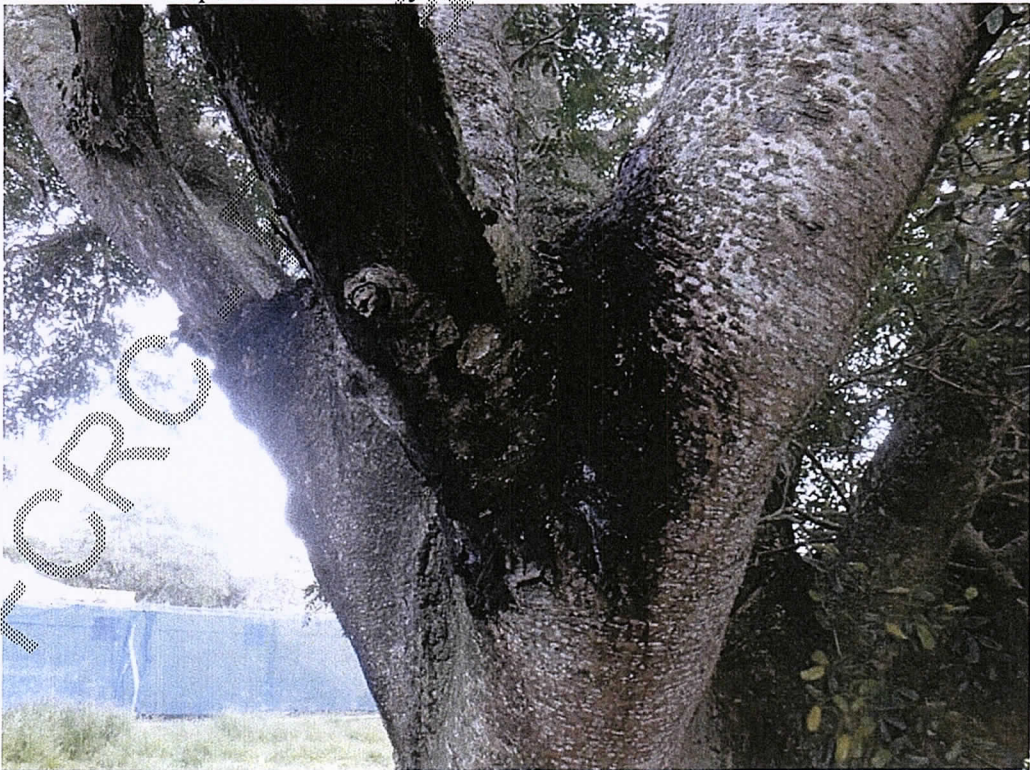
Evidence of suspect borer activity

Tree is showing signs of further decline since my last report. It is evident that deadwood and diseased branches due to borer activity has increased. Tree has had some significant previous limb failures throughout the canopy.

At some previous pruning locations and previous branch failing point's tree displayed poor wound wood development and appeared to be struggling to compartmentalize.

- Aerial inspection to be undertaken to check timber integrity throughout entire canopy.
- The removal of all defective branches, deadwood and general pruning
- Under storage planting, mulching and land scaping from the trunk out to the drip line of the tree to alleviate root compaction and to isolate the area.
- Suitable species to be chosen for the under storage planting for compatibility and over all health of the tree.
- Strongly recommend **no** seating or structures paths etc. are erected or placed under the trees canopy.
- Place tree on a monitoring and maintenance program.

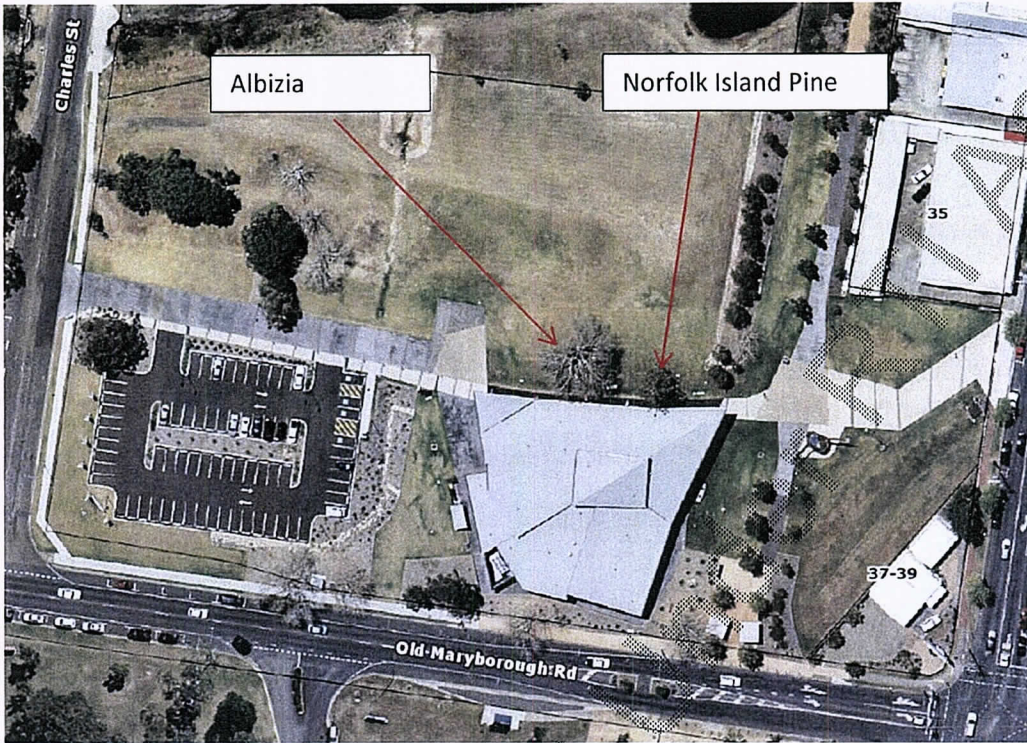
Both trees were situated in an open field until work commenced on the building of the Discovery Sphere in 2012. The base of the Albizia is located 9m from this building and the Norfolk Island Pine 3m. The trees are located to the north of the building as indicated below.
